North Riverside Public Library

Agenda
Committee of the Whole
Board of Trustees
February 6th, 2023
6:00 PM

In August of 2022, Williams Architects of Itasca, IL was commissioned by the Park Ridge Public Library to perform a Capital Needs Assessment for the Library building and site. The intent of this Capital Needs Assessment is to identify and prioritize needed repairs and modifications to the Library facility over the next ten years, with capital cost estimate information that will allow the Library to plan for likely costs of needed repairs over the next ten years.

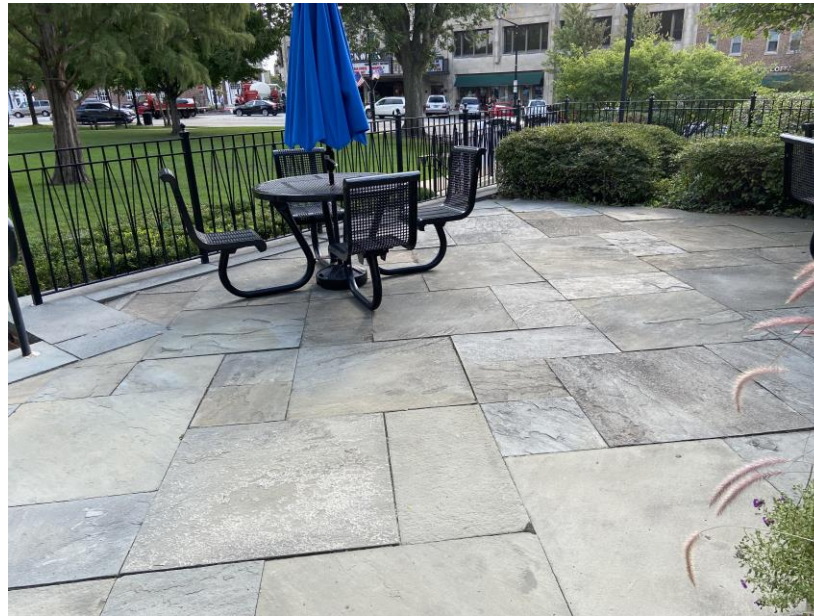
1. The bluestone patio outside the original entrance to the building is experiencing minor settlement, as evidenced by the gaps and height differential at the perimeter of the patio.

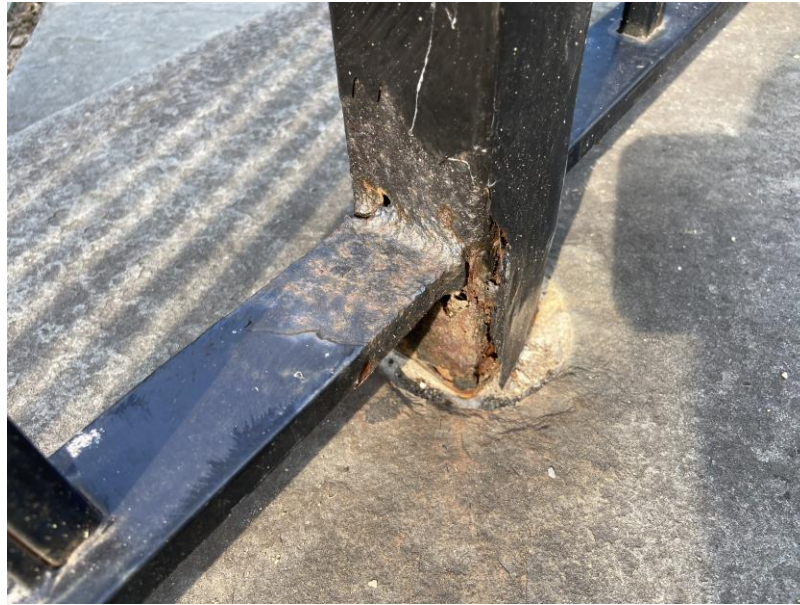
-
2. The ornamental metal fencing is severely corroding at several locations. Some of the original railings in this area do not comply with current codes.

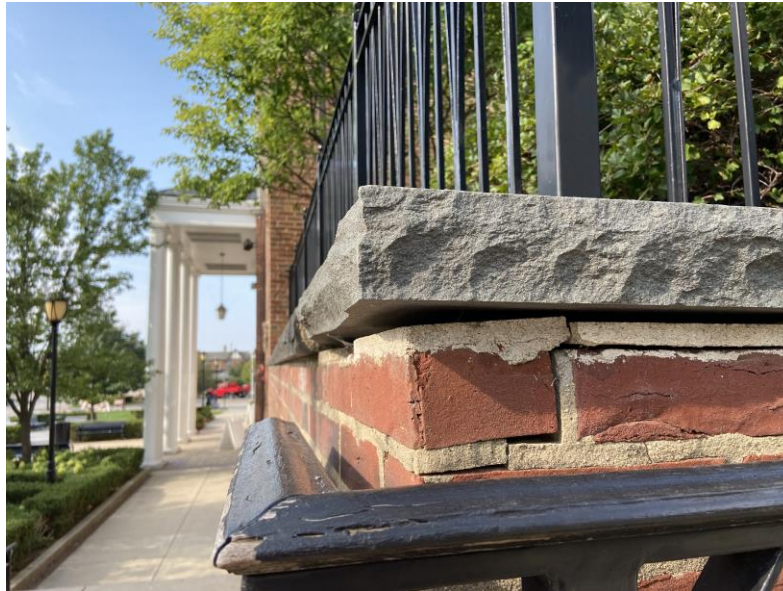
-
-
3. Masonry walls and caps at this area are loose and deteriorated, evidencing moisture infiltration.

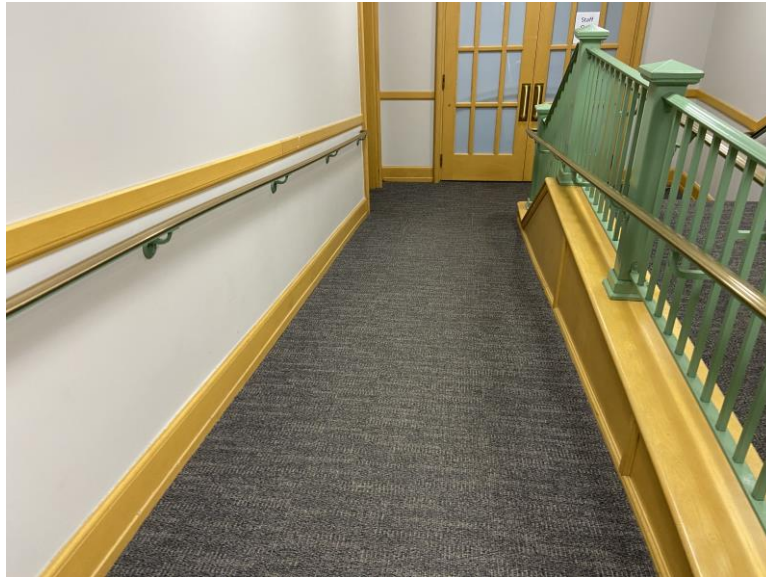
4. The slope of the existing ramp from the lobby to the meeting room level is approximately 13 percent (maximum allowable = 8.33 percent). Therefore, there is currently no accessible route to this level of the building.

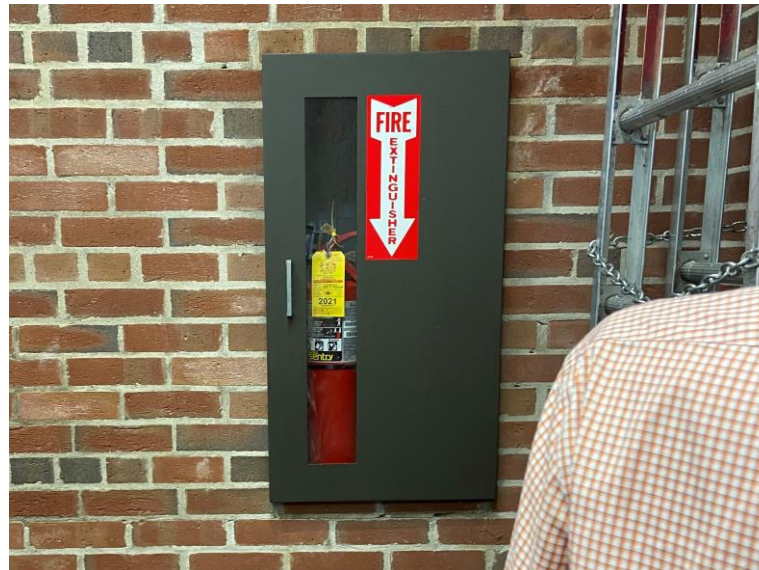
5. Several existing fire extinguisher cabinets are mounted above accessible height.

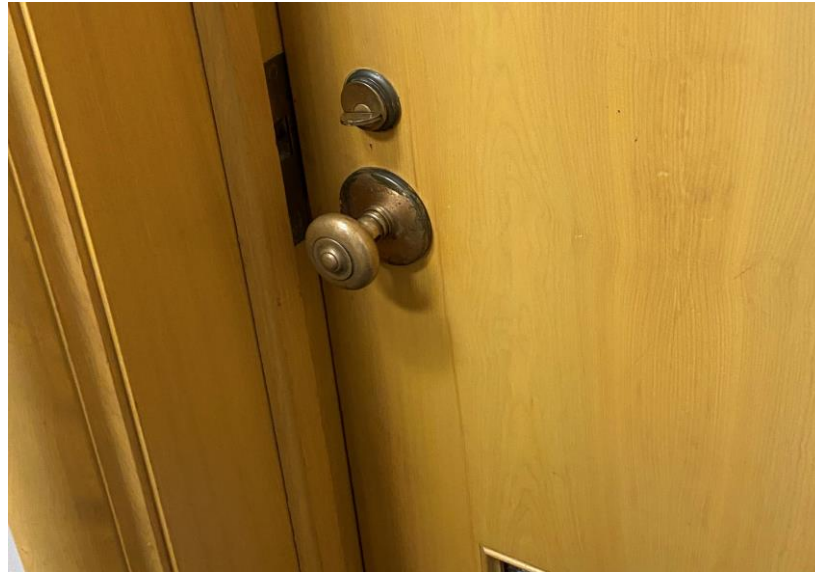
6. Some knob-style door hardware still exists in the building. While this is primarily limited to staff areas, there is no exclusion in accessibility codes for employee areas.

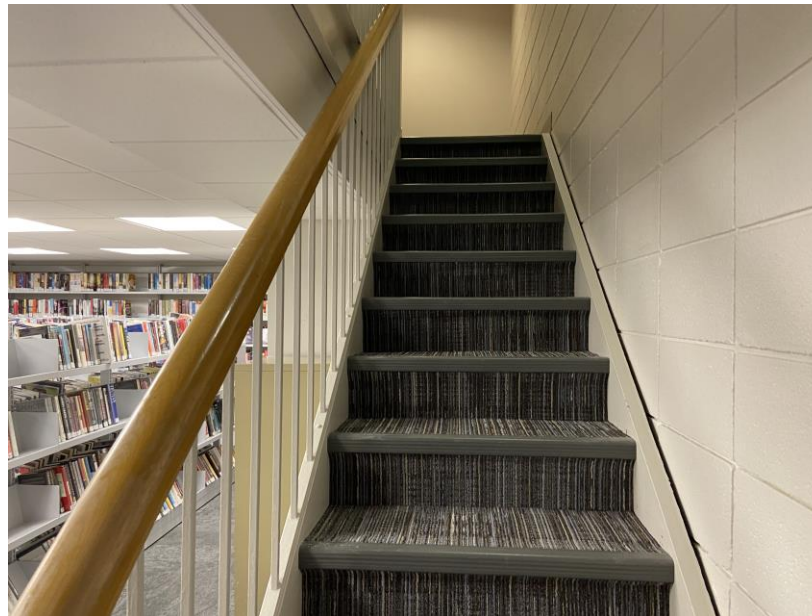
1. Stairs from the third floor to the second floor (other than the main stair connecting all levels) are non-compliant for egress width and railing/handrail design.

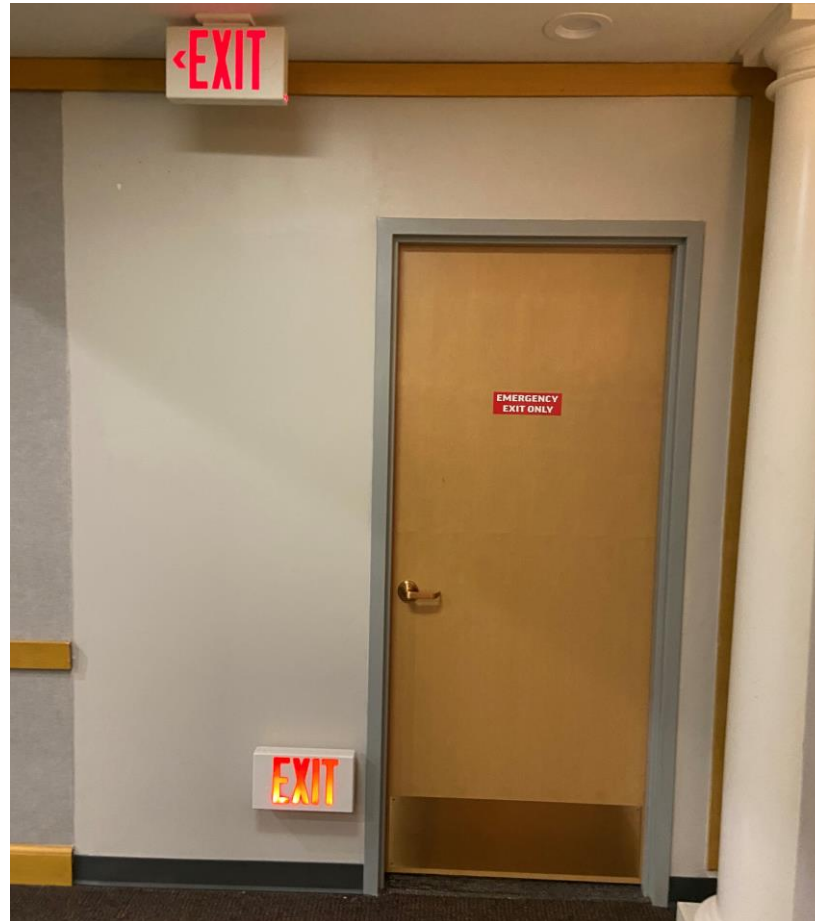
2. There are several areas in the building in which exit signs are not immediately visible, yet several locations exceed code requirements and/or are redundant. Further investigation is needed by our team to determine what determined the current configuration/installation.

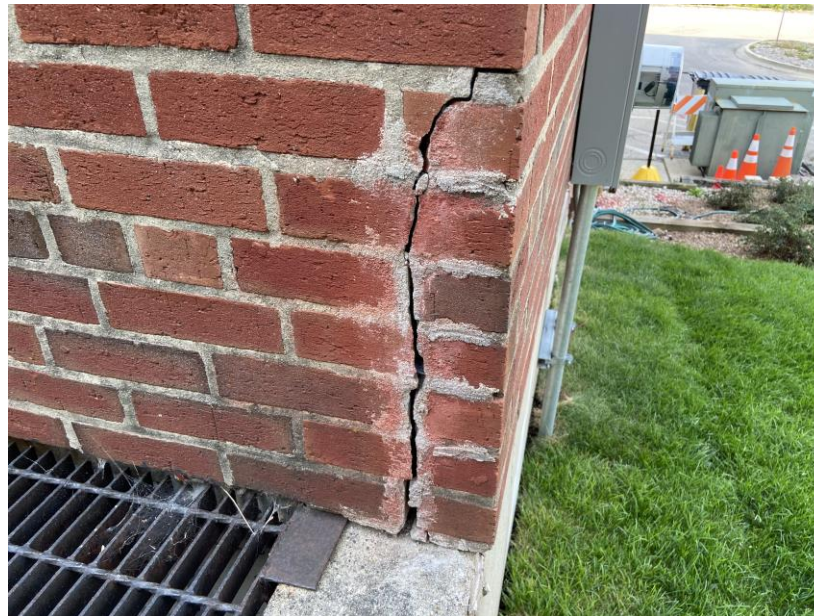
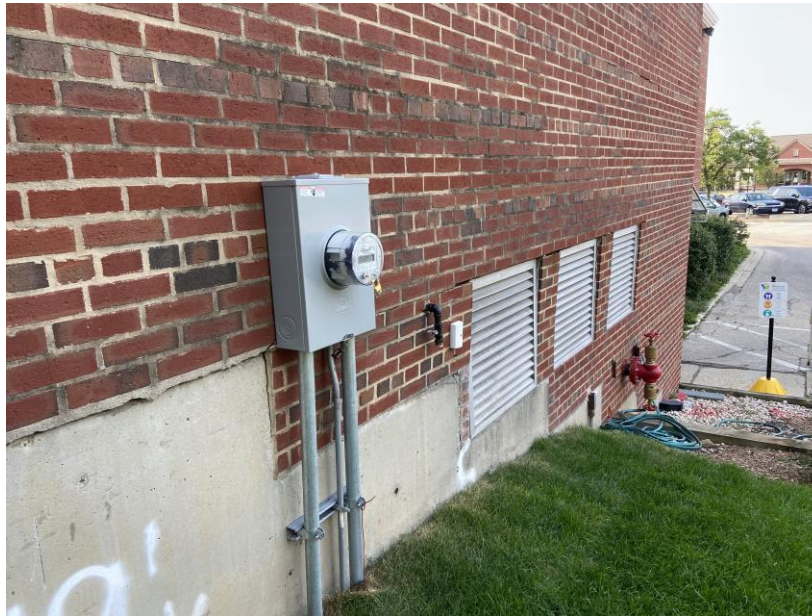
1. The masonry enclosure wall around the air handling unit at the northeast corner of the building is failing structurally. Water infiltration at the top of and through the wall has led to serious masonry and mortar damage and section loss at the steel lintel supporting the opening for louvers serving the mechanical room. The moisture infiltration has led to out-of-plane movement of the outer wythe of masonry which has led to cracking and potential structural instability of the entire wall. Additionally, cracking is visible below the wall inside the mechanical room below the space. The most probable explanation for the condition is that the in-wall metal ties that bind the inner and outer wythes of brick together are failing due to corrosion, leaving the exterior wythe of brick unsupported. While it may be possible to perform forensic investigation to confirm these findings and explore repairs, we recommend demolition and reconstruction of these walls with new masonry walls with proper ties and moisture mitigation provisions. The lintel above the louvers in the mechanical room should also be replaced as part of this work to ensure future structural integrity of the opening.

Exterior wall - discoloration and movement/out-of-plane masonry visible

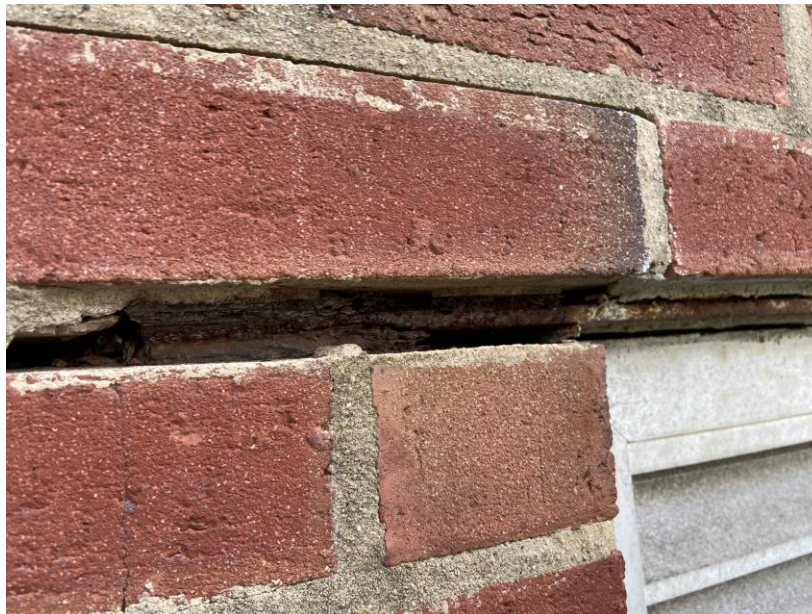
Section loss at steel lintel supporting openings over exterior louvers

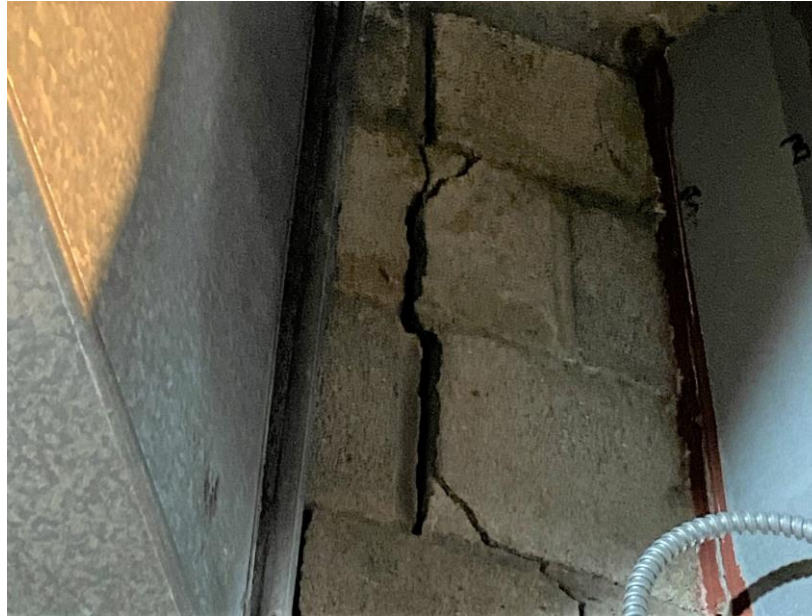
Cracks in concrete masonry at interior, between exterior louvers pictured above.

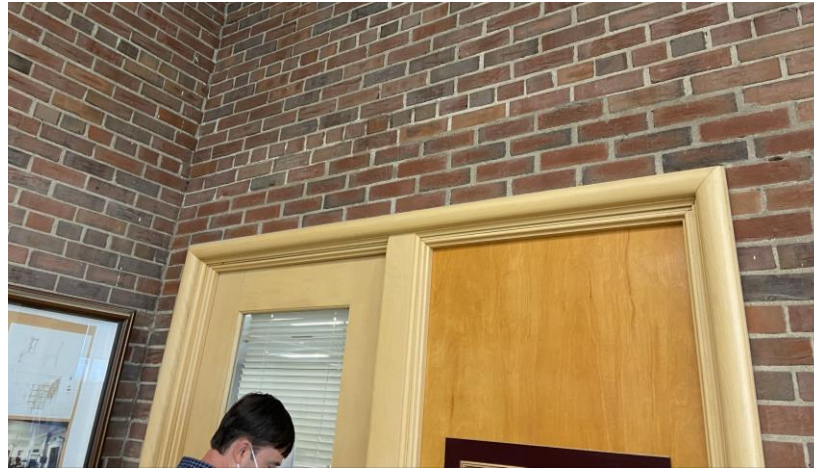
2. Several lintels over door openings on the interior of the building are incorrectly located or altogether missing. Original 1977 drawings were examined, and original plans called for steel lintels at these locations, yet none (or any alternate equivalent structures) were observed. Though typical masonry structural “arch” action makes these conditions very unlikely to be of any danger, these openings must be properly supported by steel lintels or masonry bond beams designed by a licensed structural engineer.

Example of unsupported masonry opening at interior door

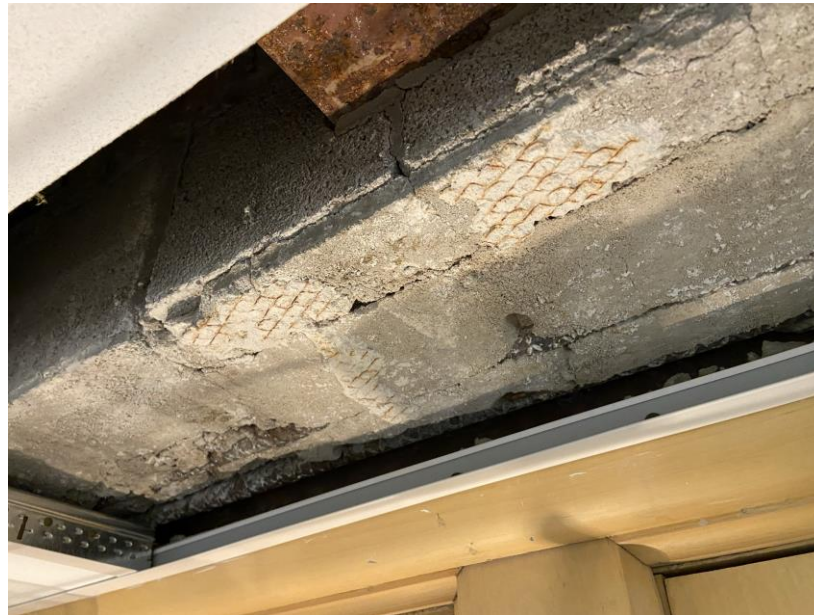
Example of unsupported masonry opening at interior door

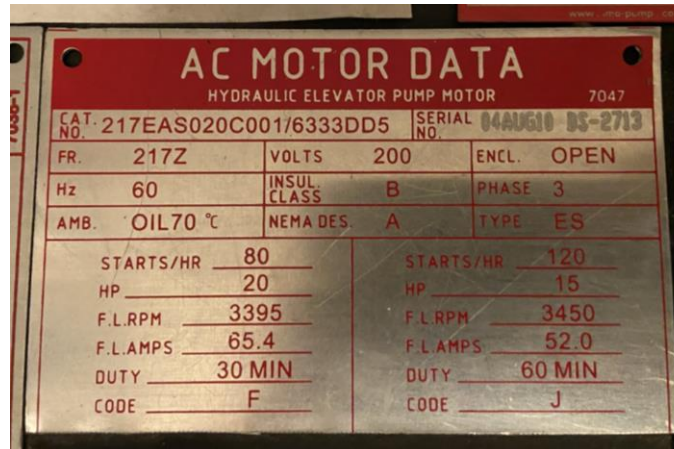
Elevator pump motor was manufactured in 2010 and replaced between 2010 and 2011.

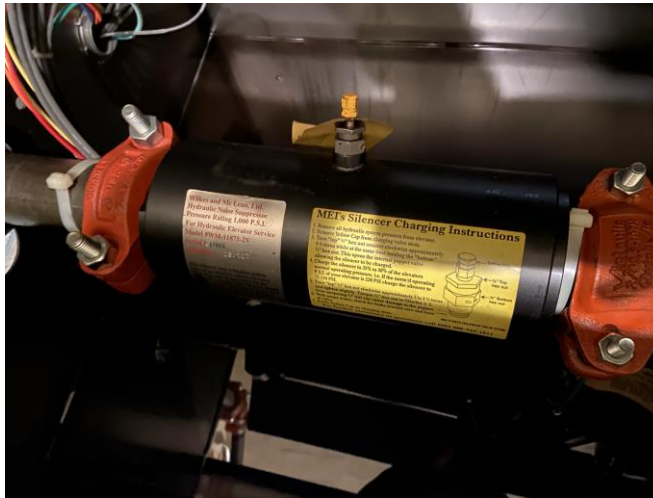
A hydraulic silencer was added as part of the modernization in/around 2011.

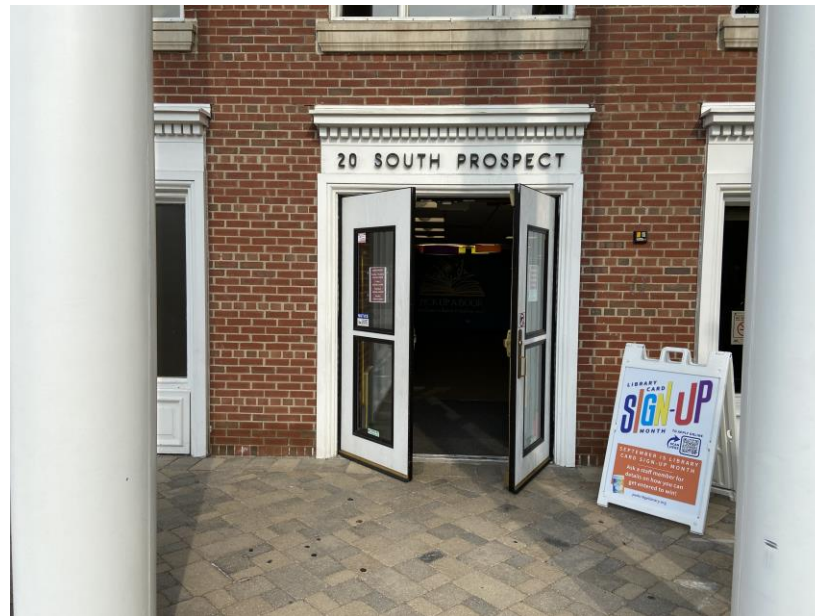
1. Though an exterior entrance vestibule was recommended by the previous capital needs assessment and identified as a potential scope item in the 2018 renovation, this work was never completed due to space considerations. Addition of a vestibule would increase thermal comfort in the building lobby and likely would need to occur outside the building footprint, altering the exterior appearance of the building. (Alternatively, an air curtain could be installed inside the entrance doors if overhead space permits)

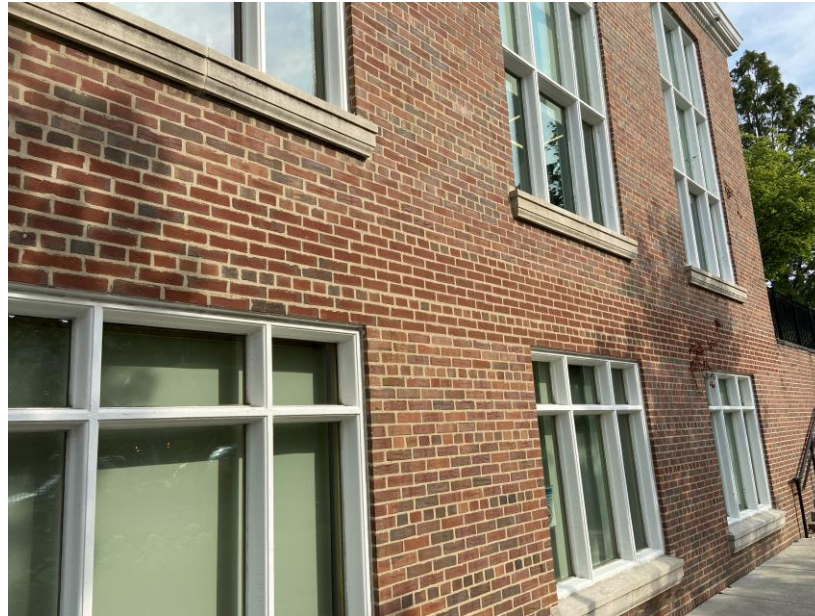
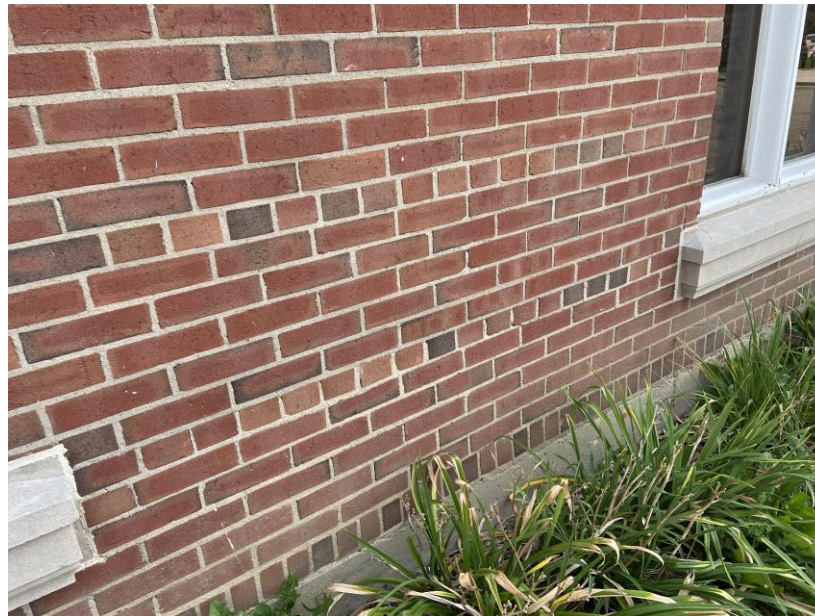
2. Approximately 15 percent of the existing exterior masonry requires tuckpointing due to weather-related mortar loss.

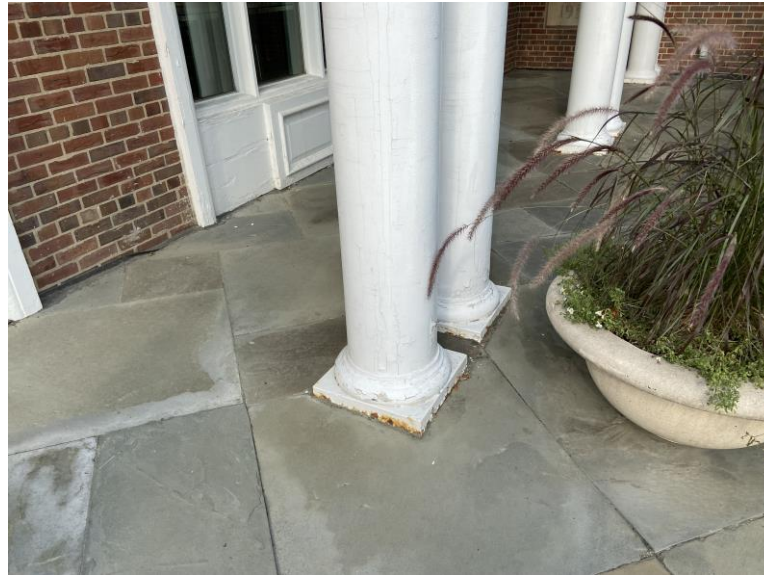
3. Wood columns on east side of building (original portion of the building) are deteriorating and require replacement with products similar to the recently replaced main entrance columns. Alternatively, they may be sanded, filled, and coated with a high-quality exterior coating.

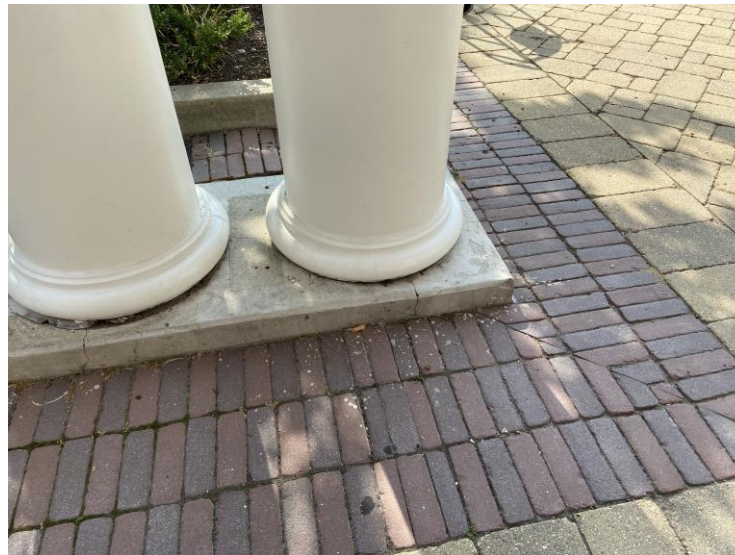
4. Though the column covers on the south (entrance) side of the building have been recently replaced, the concrete column bases at these locations are cracked and deteriorating.

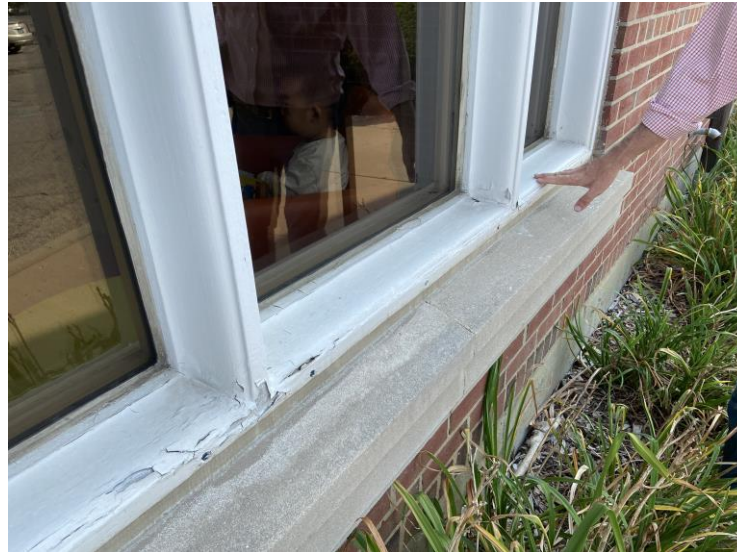
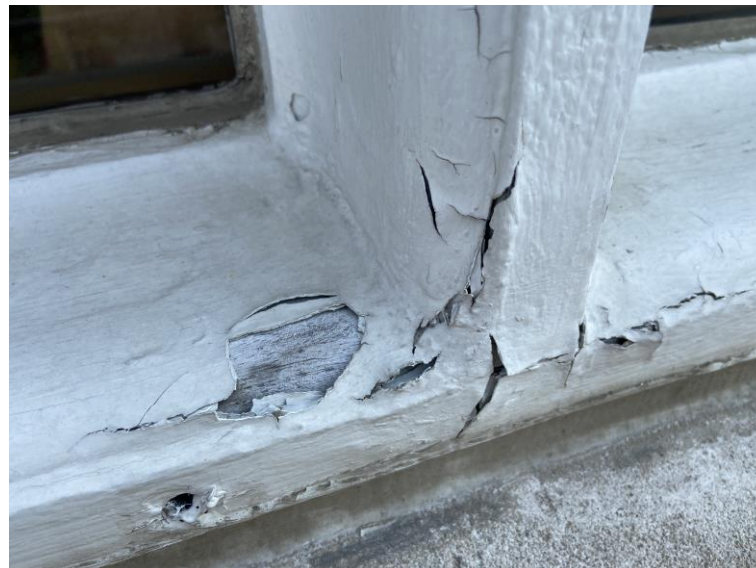
5. Several exterior window openings require repair or replacement of the exterior window trim and sealant. Though numerous repairs have been made over the years to extend the life of these windows, the long-term solution of replacing exterior wood trim and existing glass panes with aluminum clad window units as has been completed at the north side of the building at two window locations is recommended for all windows.

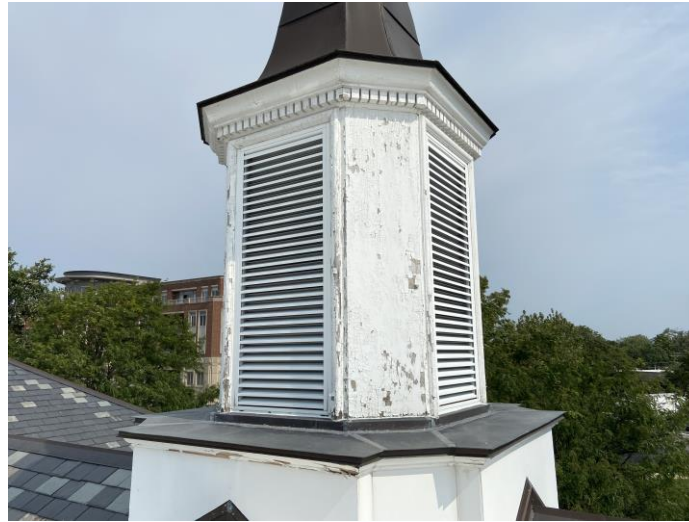
6. The cupola on the building's roof should be scraped, prepared, and re-painted with a high-quality exterior coating.

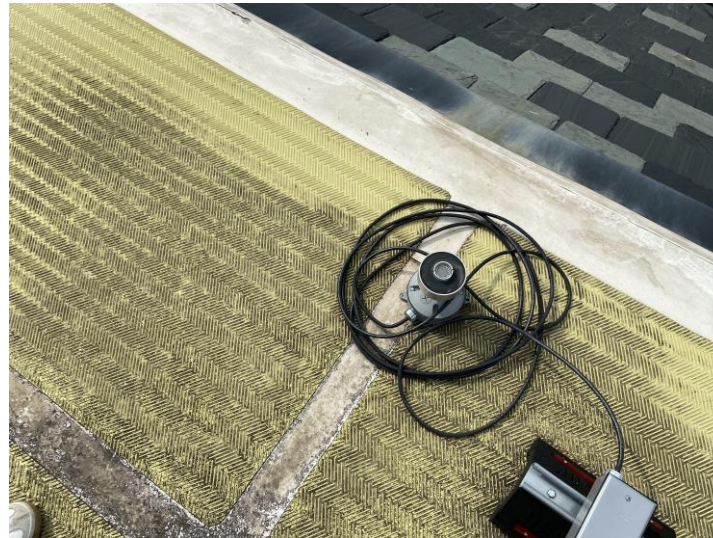
7. The building's roof is in excellent condition. The snow sensors for the snow/ice melt system are loose should be secured to the roof. (Library staff report that the system is being tested and the sensors will be secured by the contractor following testing)

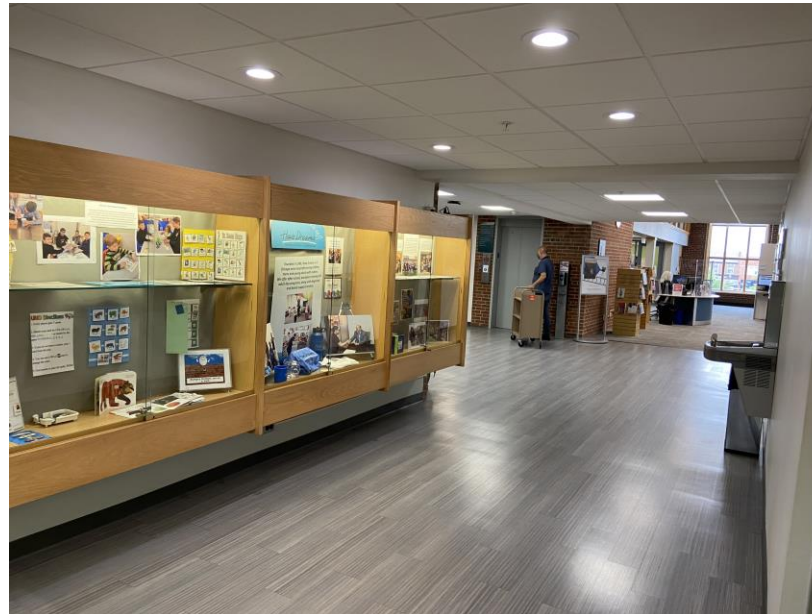
1. Though nearly all interior finishes were recently replaced and are being maintained properly, lighter-colored carpets and LVT materials are starting to show some early signs of wear. LVT outside the administration offices on the second floor is of lower quality and floor preparation imperfections are telegraphing through to the surface.

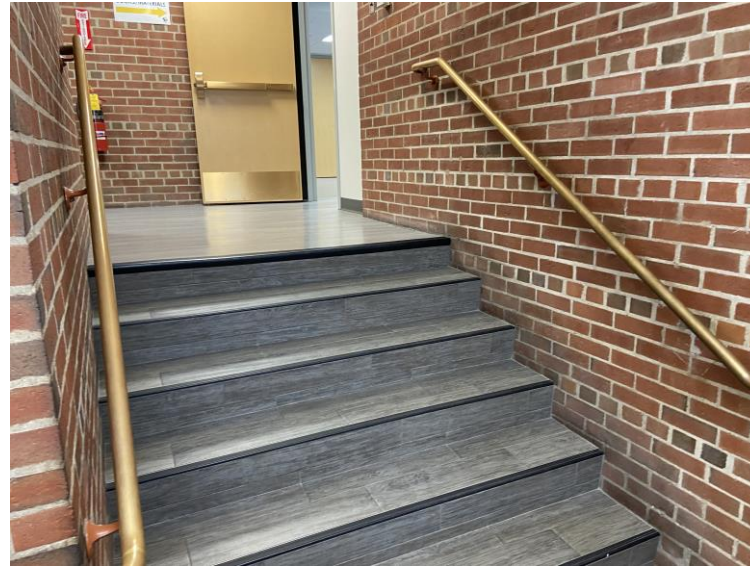
2. Rubber insert nosings at main stairs are likely not a good long-term solution for a stair with heavy use and will need to be replaced more frequently than if integral stainless steel nosings were installed.

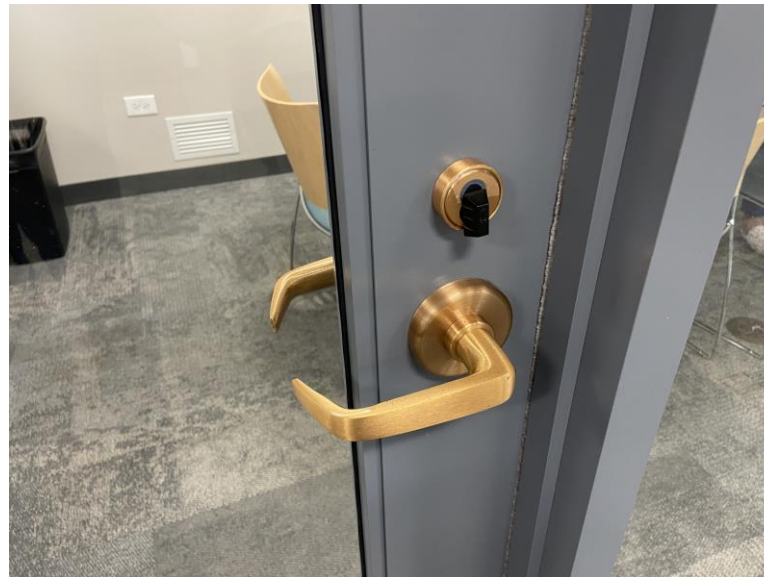
3. The second-floor study rooms do not have key cylinders installed on door hardware. Most libraries install storeroom type (lockable from outside, free egress from inside) locks on study rooms. PRPL is in the process of replacing cylinders.

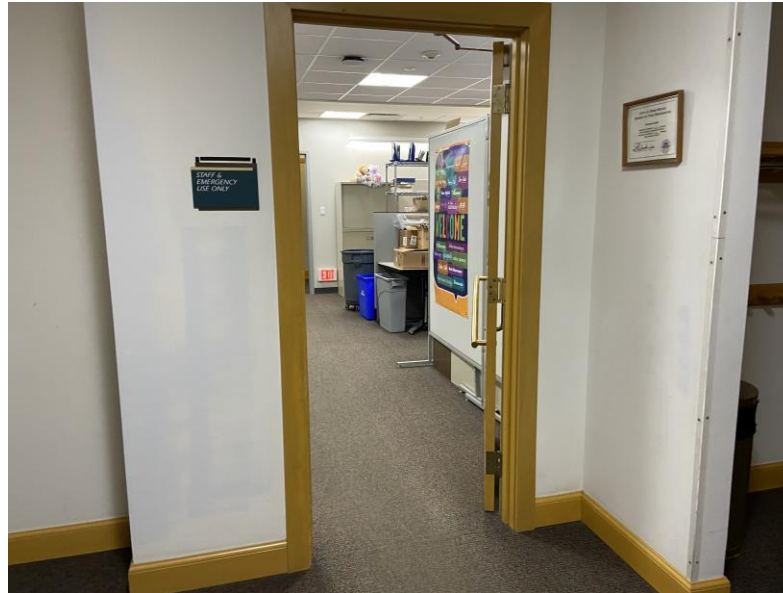
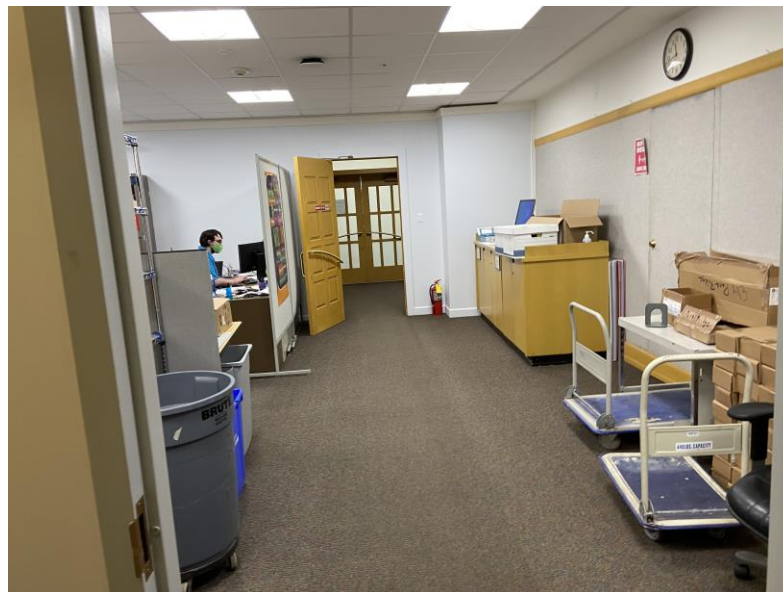
4. Many finishes require replacement in areas that were not renovated during the 2018 renovation project. These areas include the first and third floor meeting rooms, first floor staff areas, and restrooms in Youth Services.

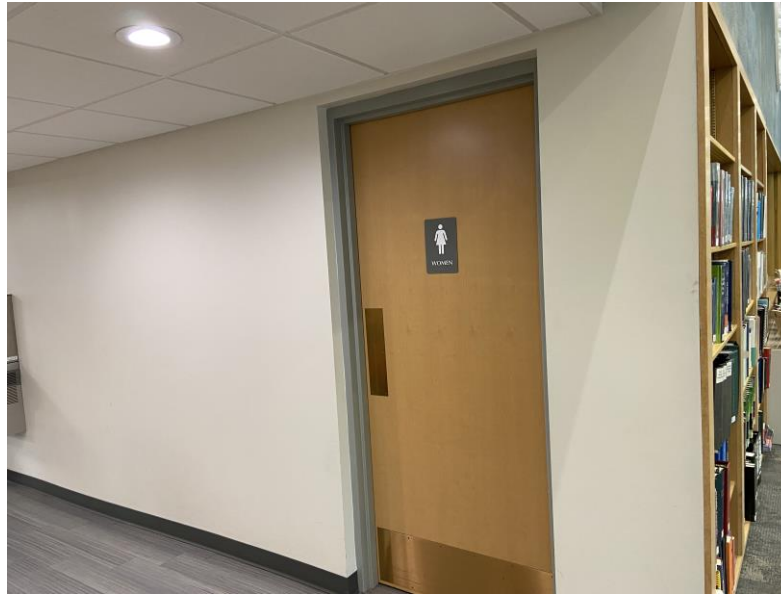
5. Corner guards and wall protection panels are not present at most high-traffic and high-abuse areas at drywall partitions.

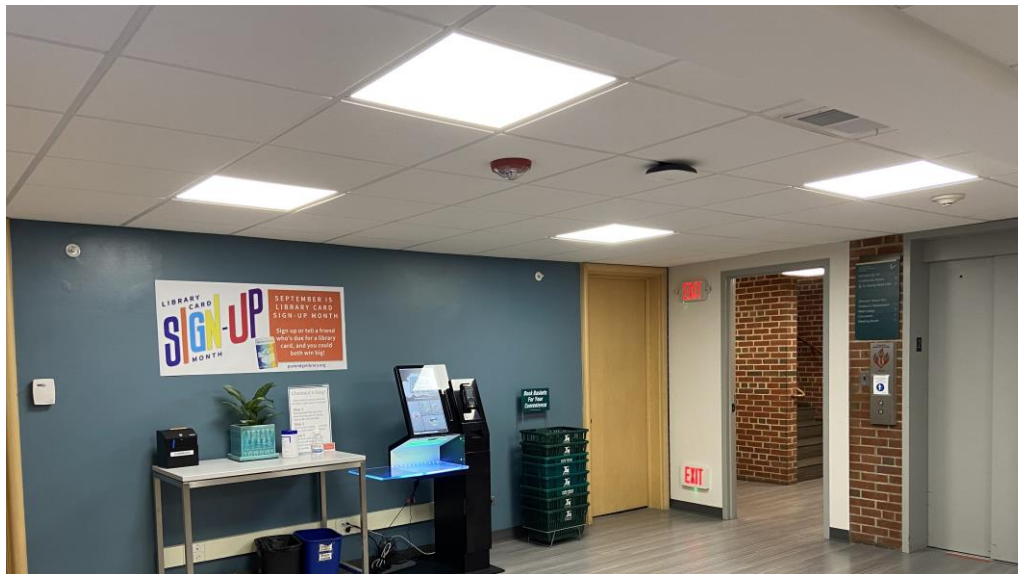
6. Though the door from the main stairwell to the second-floor lobby area is technically code compliant, it is a severe “pinch point” for a high traffic area and should be a wider door to facilitate movement throughout the building. We recommend removal of the existing door and frame and replacement with a new door and frame 8 to 10 inches wider.

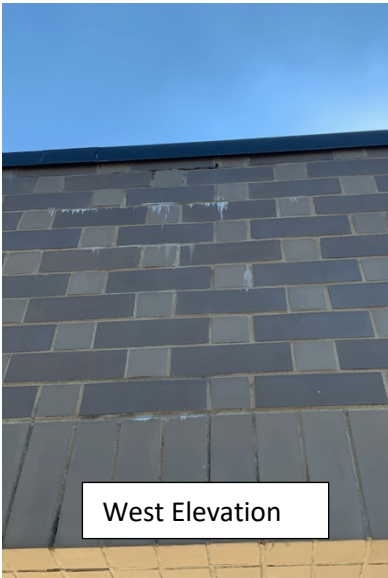
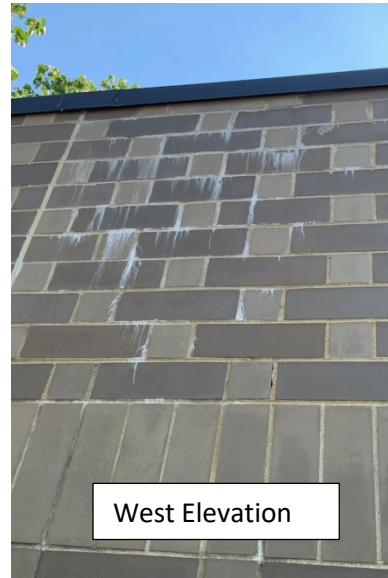
West Elevation

Masonry – the brick work on the building is in good condition overall with minimal current need for tuckpointing. Even with the little identified, we recommend patching it to prevent it from getting worse. And, with all masonry it will need some patch and repair over time. (A1) See Sealants section below for masonry control joints.

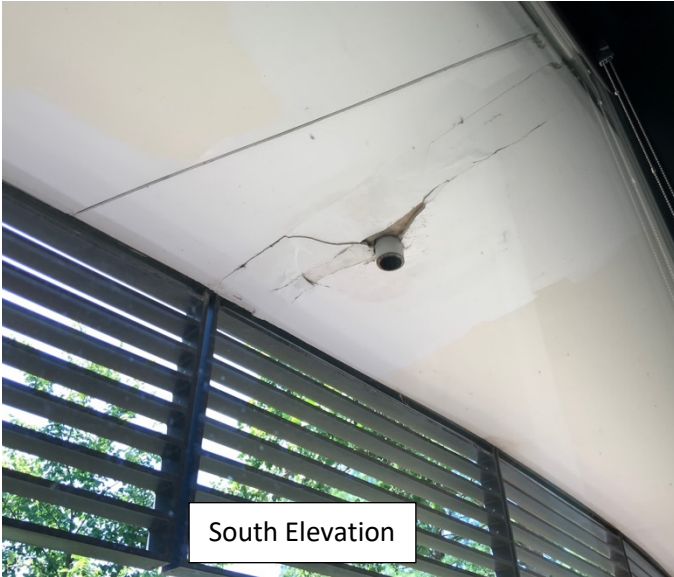
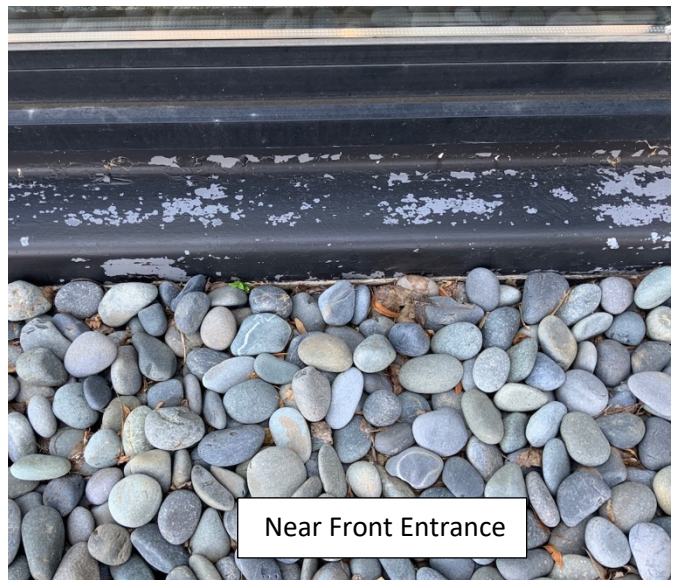
South Elevation

Exterior Painting – The building has several areas that have a painted finish including the underside of soffits, fascia, exterior windowsills, metal doors, etc. These areas should plan to be painted about every 7 years or as required to maintain both aesthetics as well water resistance. Note some areas of the soffits have drainpipe penetrations with cracking in the surface. These areas need patching with a durable, exterior plaster material prior to painting. (A4)

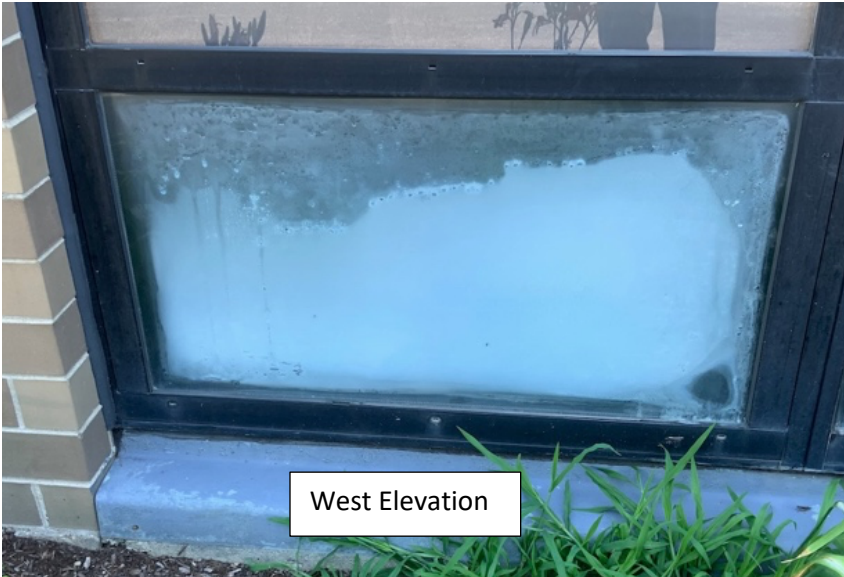
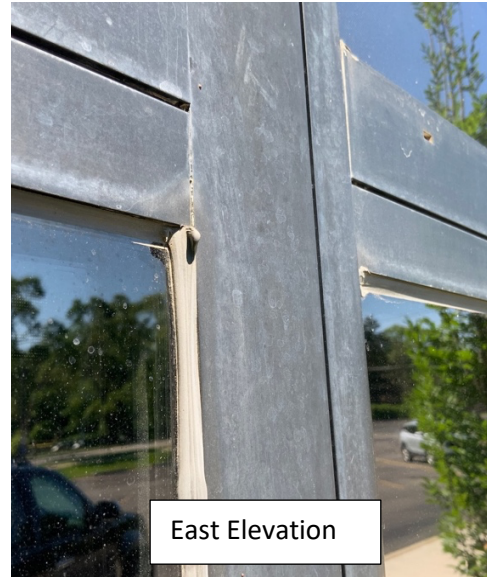
Windows – the windows are all commercial grade aluminum frames with insulated glass and are in good shape. The gaskets between the glass and frame are not showing signs of shrinking or have been “wet sealed” (with sealant) which is an effective solution. Under certain conditions (heavy rain from certain direction), some unprotected windows do leak (staff room most recently). These units should be “wet sealed” (gaskets caulked). There is one glass unit with a blown glass seal causing the glass to become cloudy. This happens periodically and those units should be replaced. (A6)

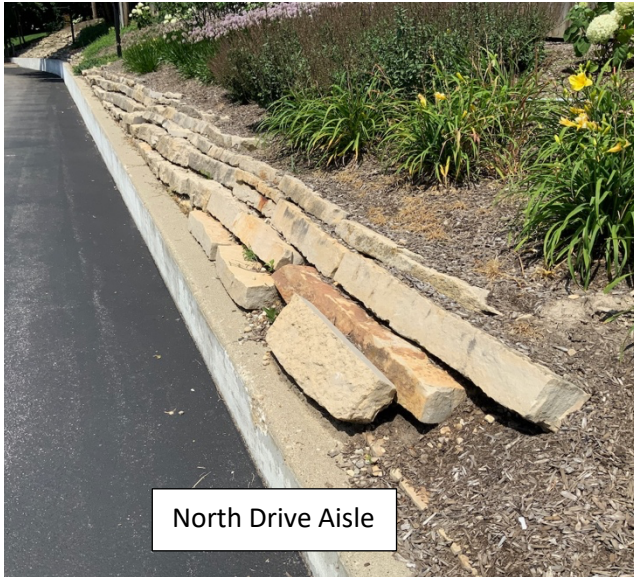
North Drive Aisle

Landscaping – The landscaping for the building is well maintained overall. There is a stone landscape wall along the north drive lane that has some loose stones and has become misaligned. Although not a significant hazard, this wall should be realigned and fixed for aesthetic reasons as well as children that may want to climb it. (A7) Additionally, there are some vines that are growing on various areas of the building. Although these vines can break up the view of a masonry wall, they can also grow into the flashings and soffits of a building causing significant damage. We recommend cutting these back yearly as a part of normal maintenance to ensure they are growing only where they are desired and keeping them away from roof edges and other places where they can cause damage.

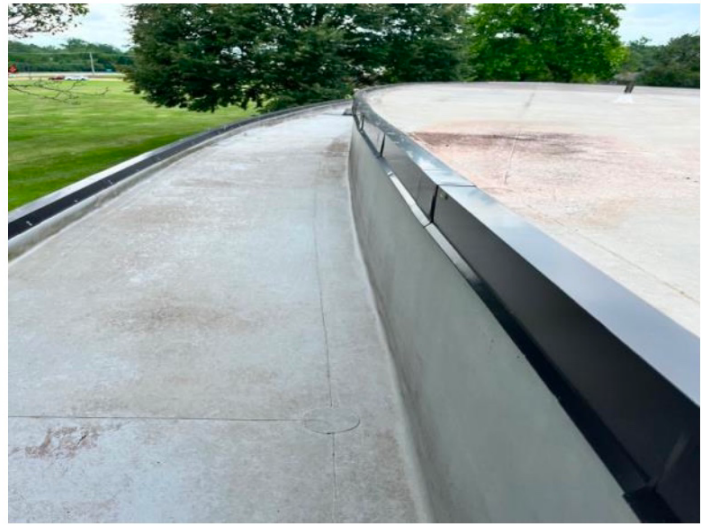
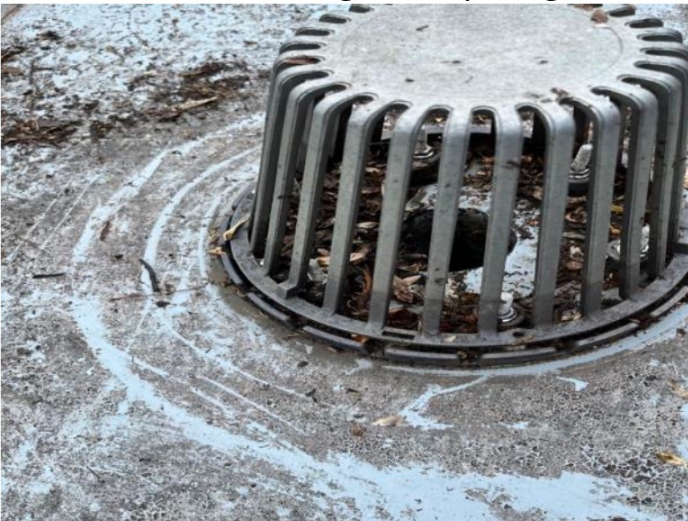
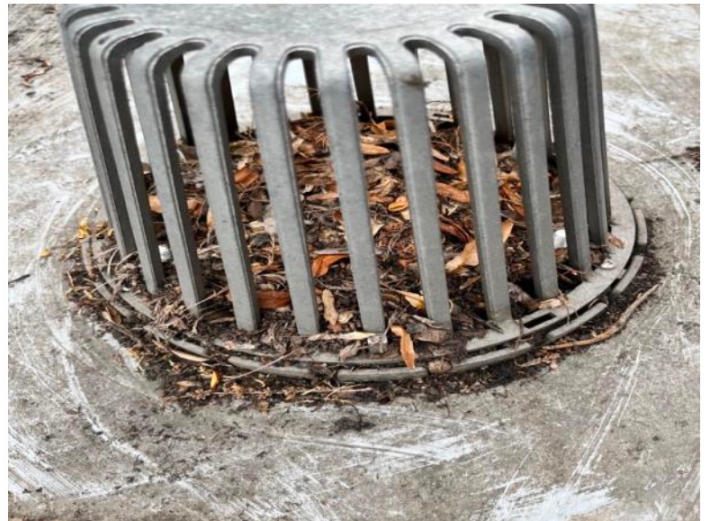
Debris covering drain opening
