North Riverside Public Library

Agenda
Committee of the Whole
Board of Trustees
February 6th, 2023
6:00 PM

In August of 2022, Williams Architects of Itasca, IL was commissioned by the Park Ridge Public Library to perform a Capital Needs Assessment for the Library building and site. The intent of this Capital Needs Assessment is to identify and prioritize needed repairs and modifications to the Library facility over the next ten years, with capital cost estimate information that will allow the Library to plan for likely costs of needed repairs over the next ten years.

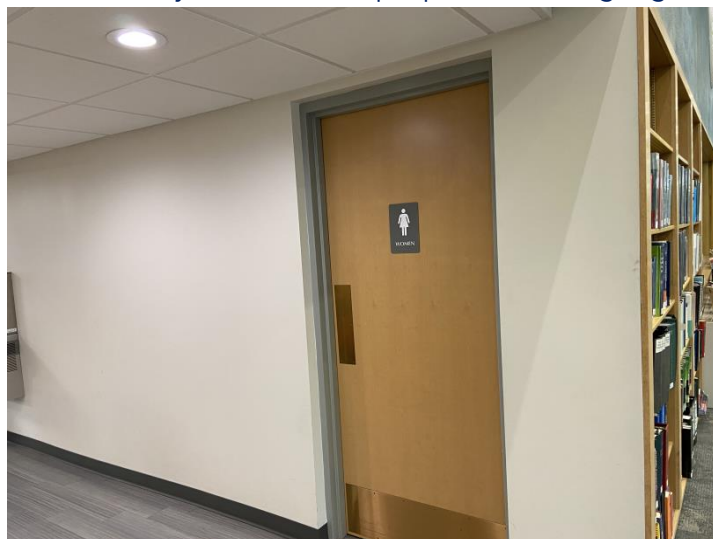
3. Very little accessible room identification signage is provided throughout the facility. The signage that is currently installed is incorrectly located on doors (rather than to the latch side of the doors as required by codes). A project is in progress to update building signage to address these issues. We have performed a cursory review of the proposed new signage and it will address these concerns.

Example of door-mounted room identification signs

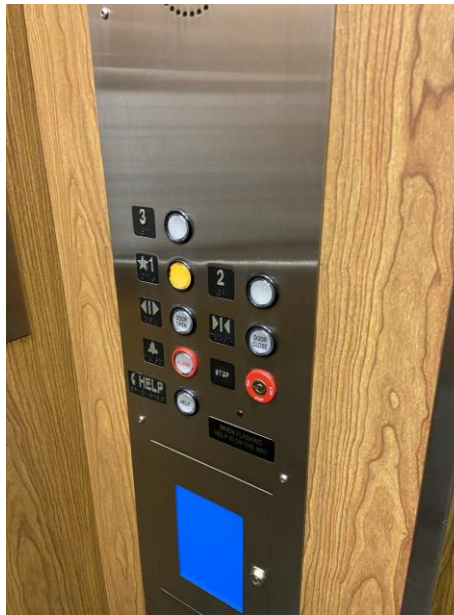
In-car controls and two-way communication systems comply with current codes.

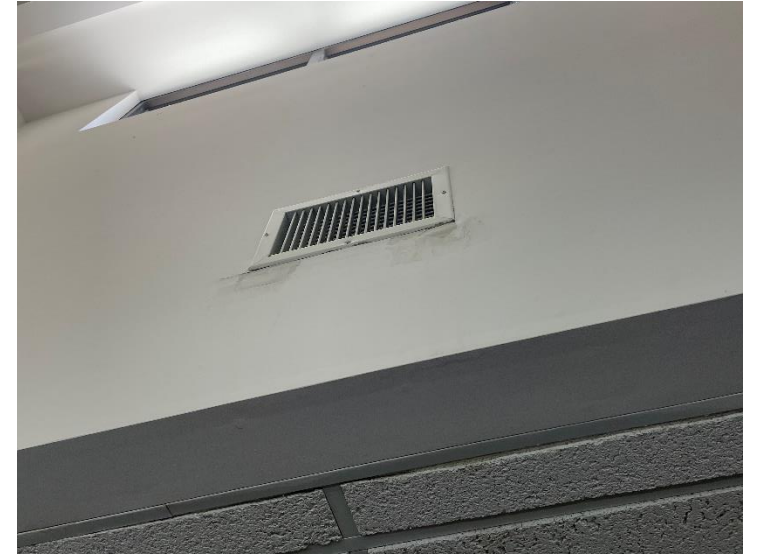
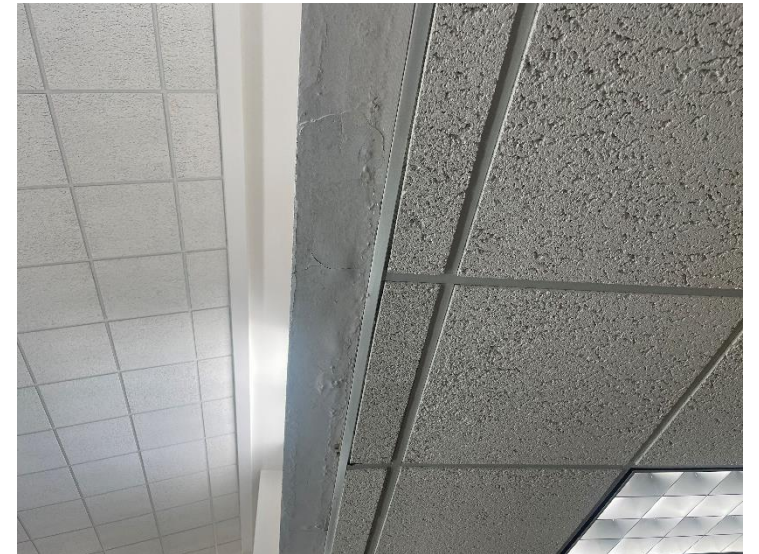
Interior Environment
Water & Mold

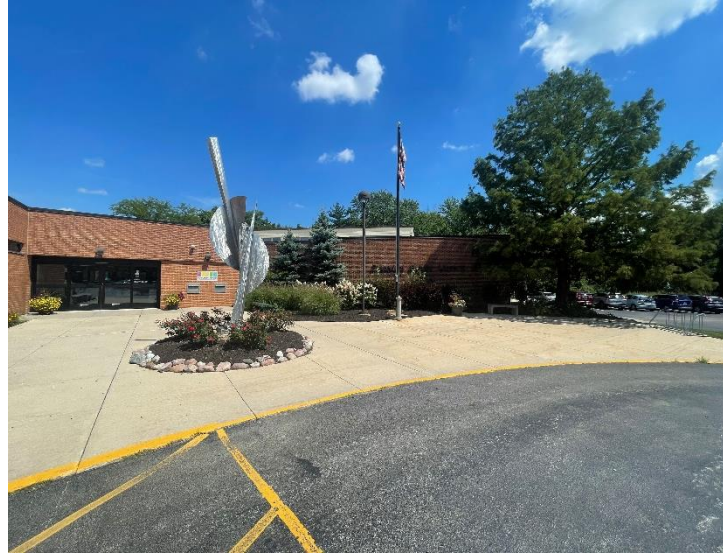
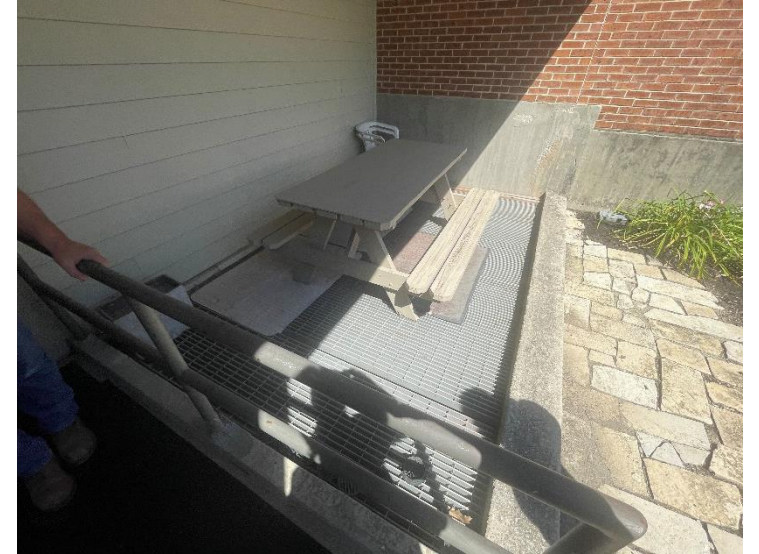
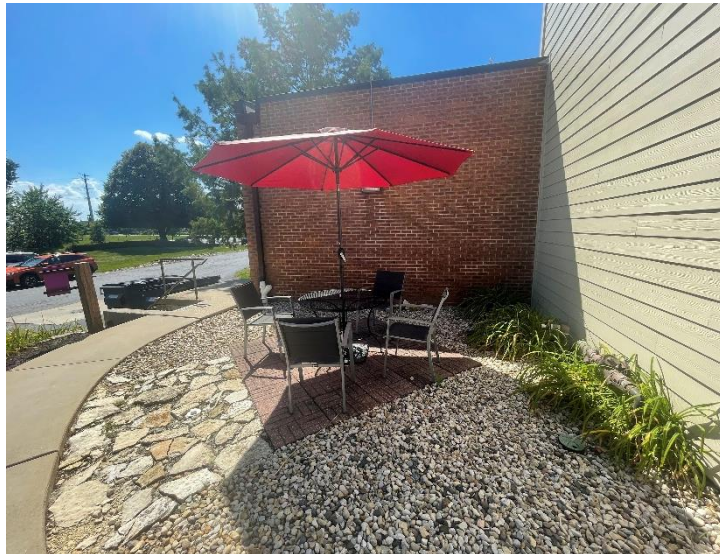
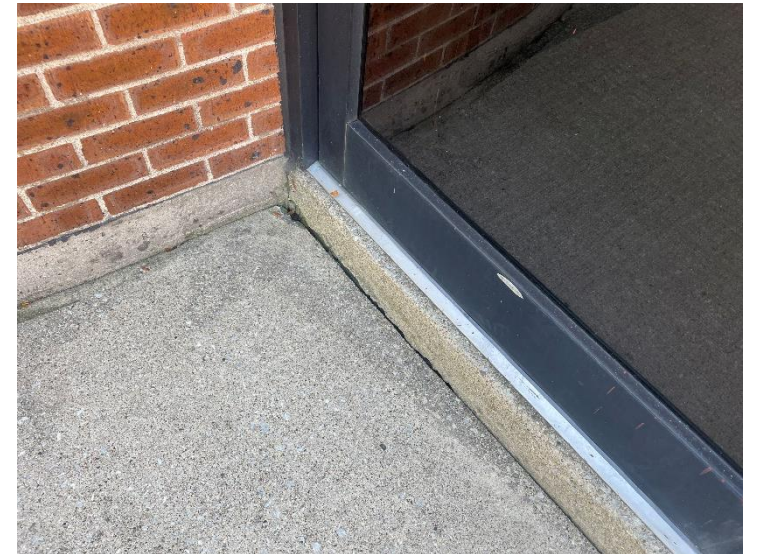
Uneven Pathways

Inaccessible Transitions

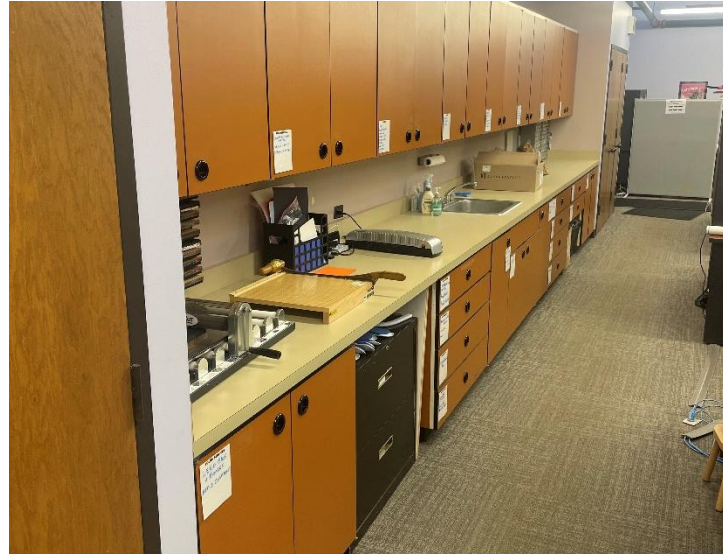
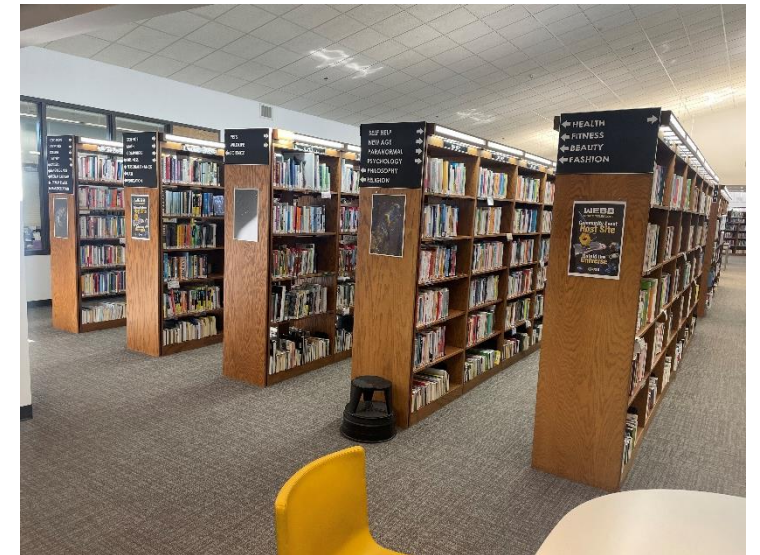
Interior Environments
Maneuvering Clearances
Space Access
Reach Ranges

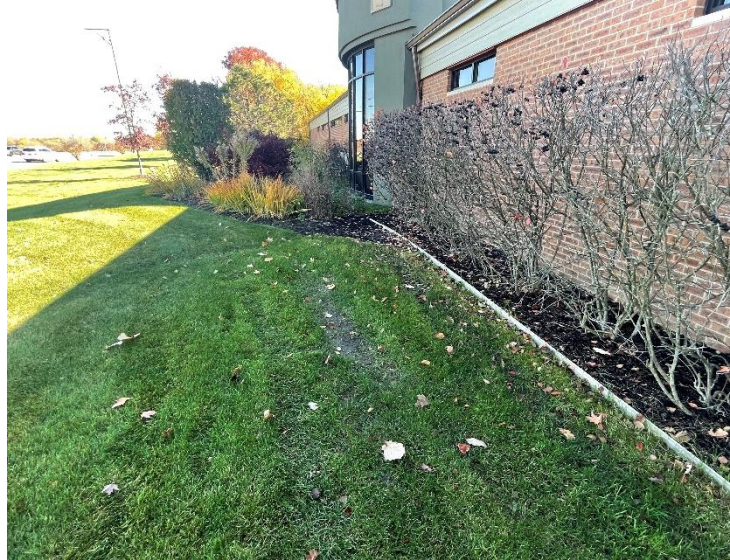
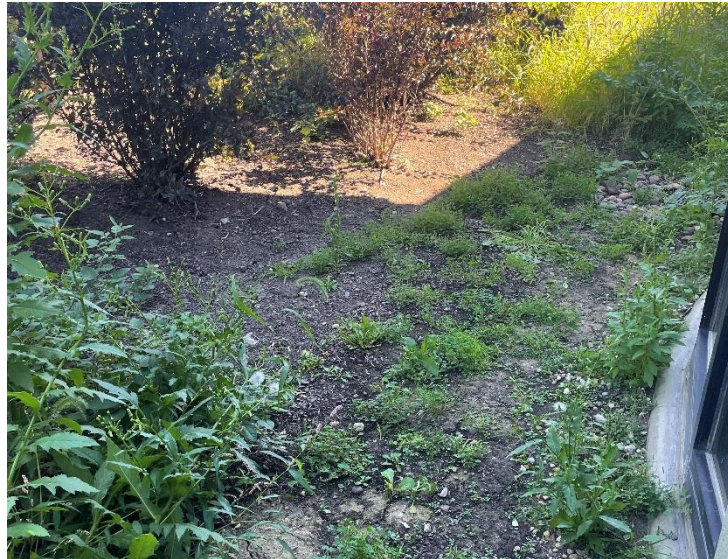
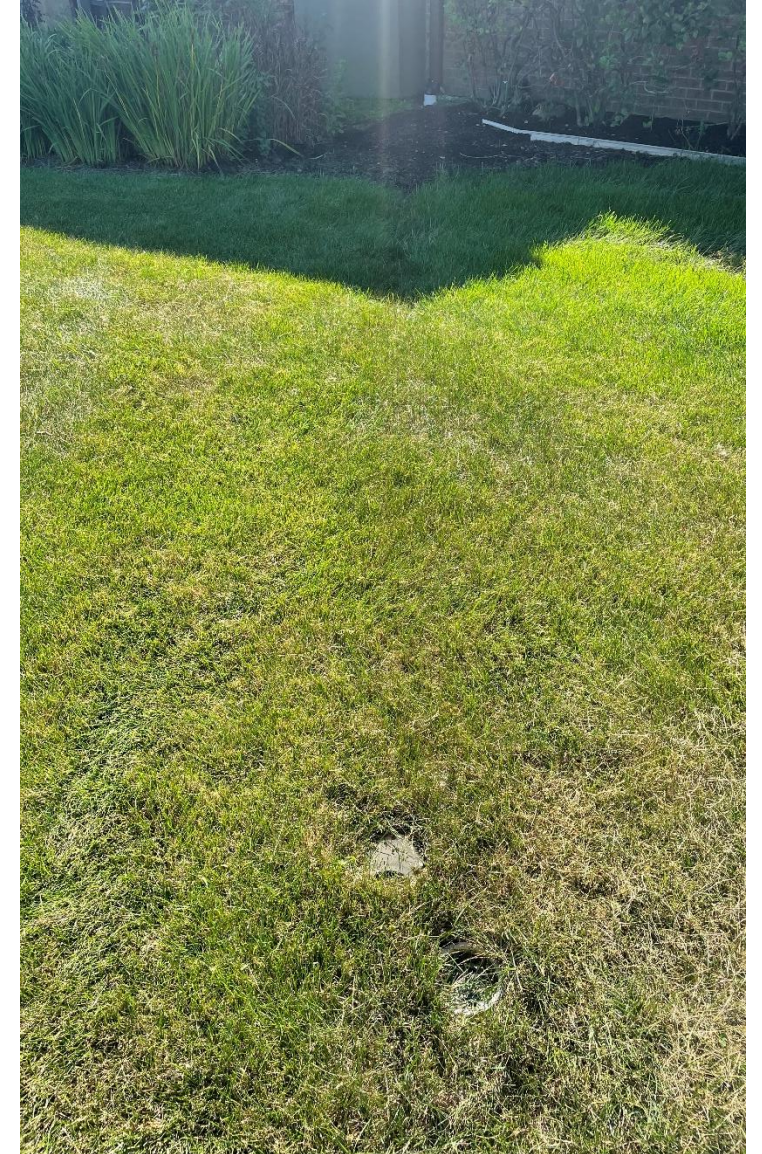
Site Grading

Site Drainage

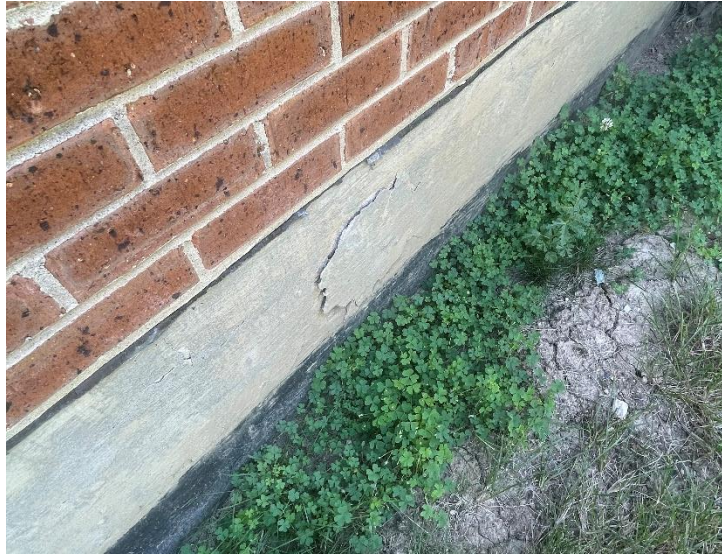
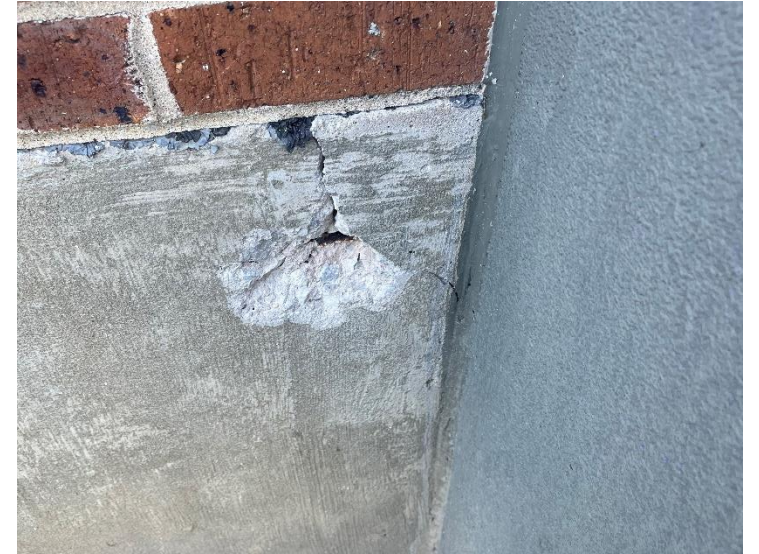
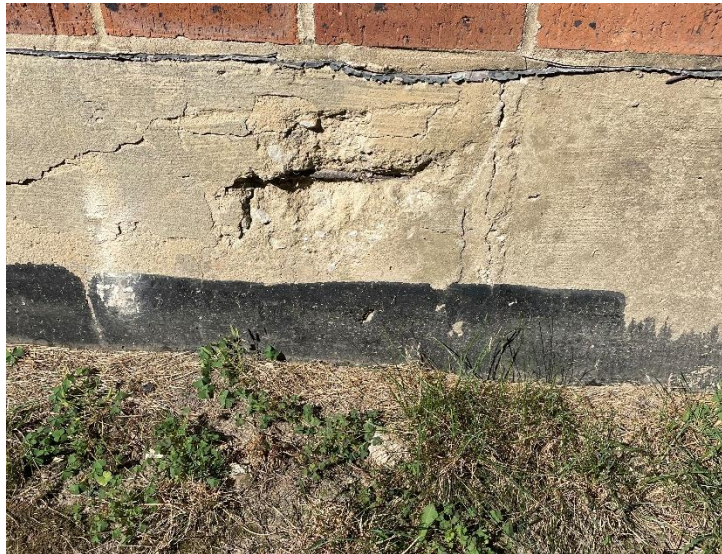
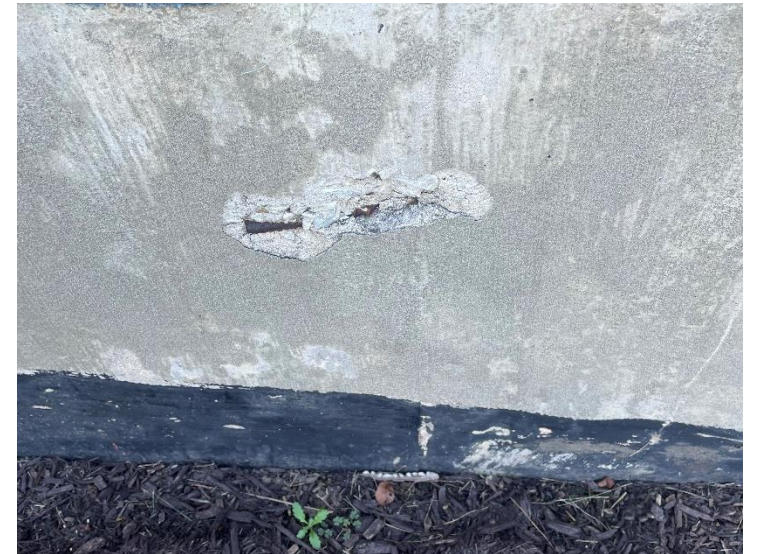
Building Envelope Wall Integrity

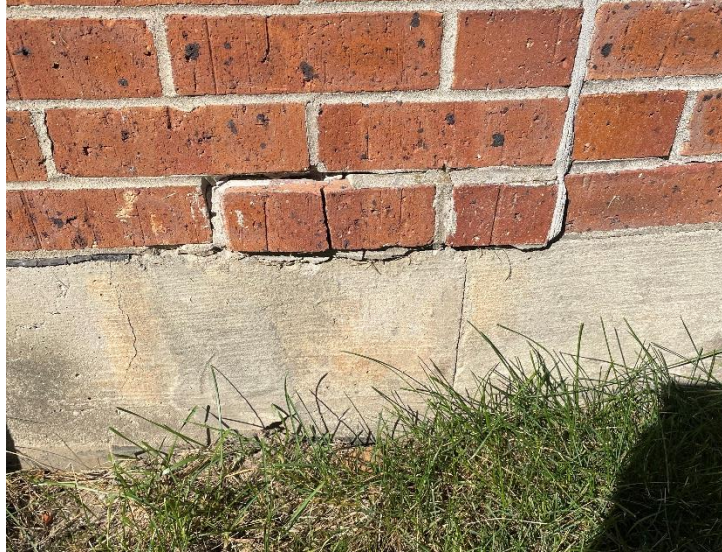
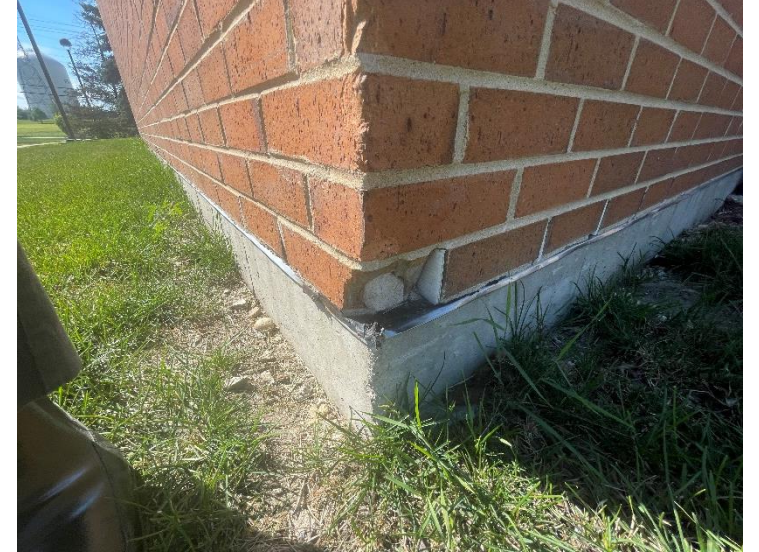
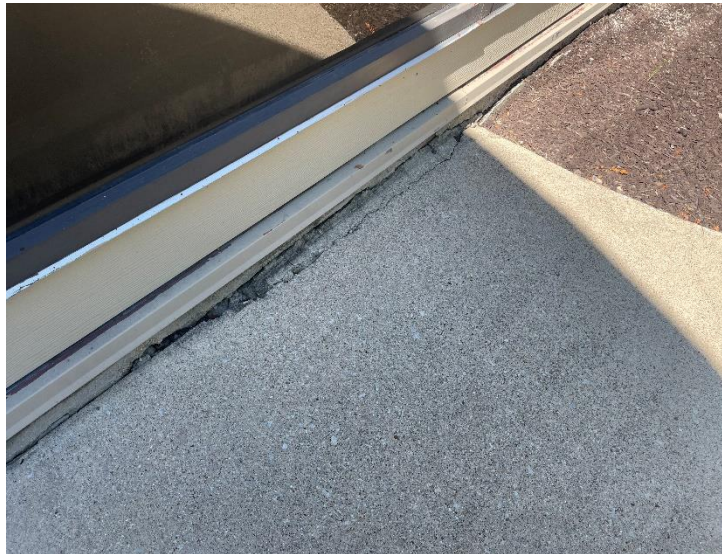
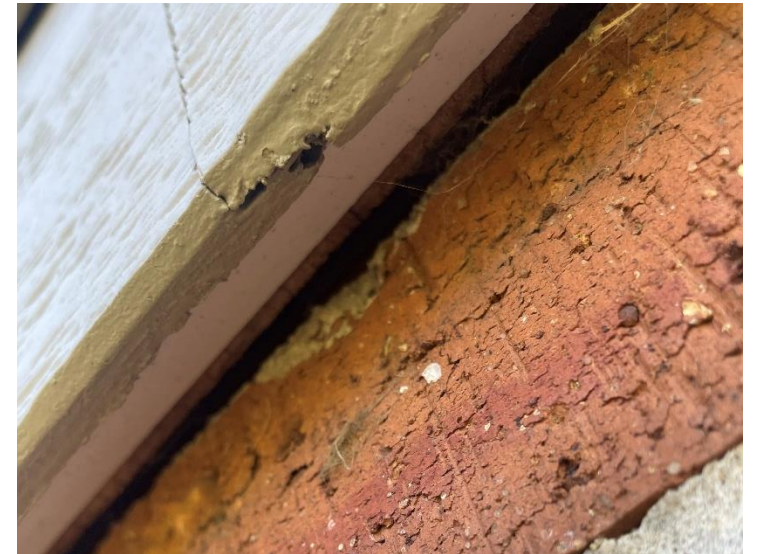
Building Envelope Wall Integrity

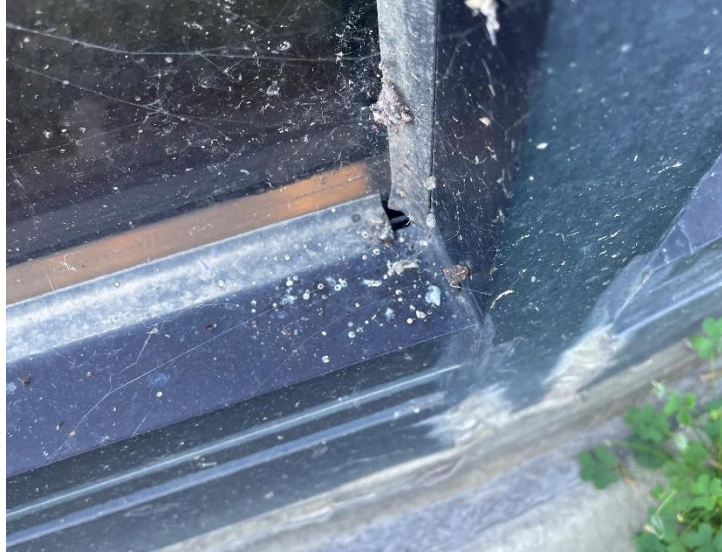
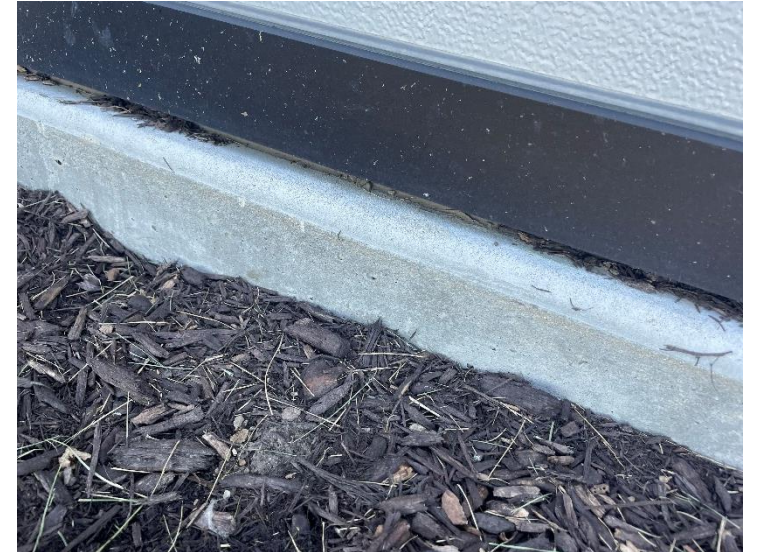
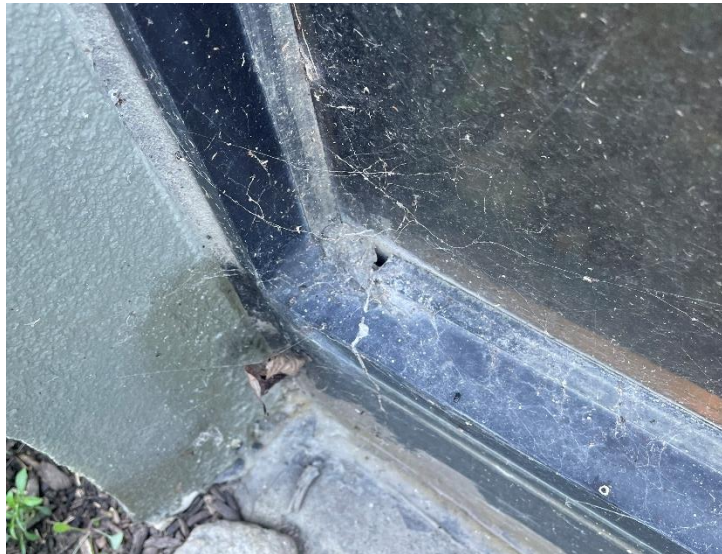
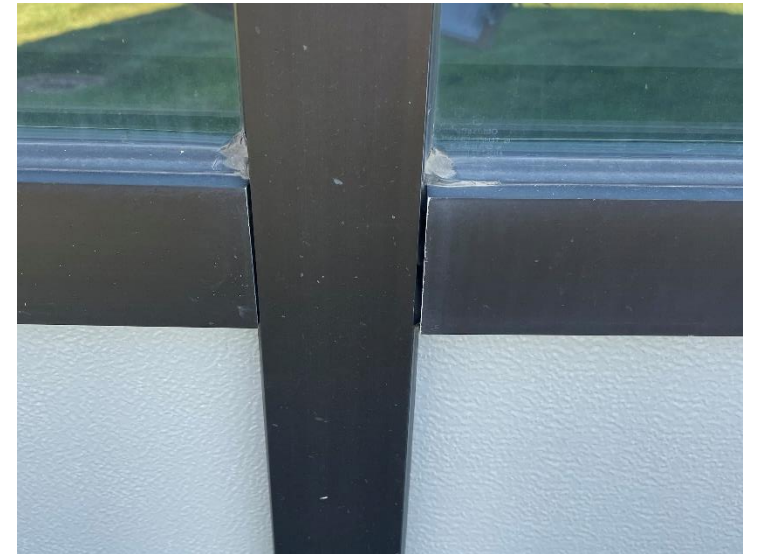
Building Envelope Window Integrity

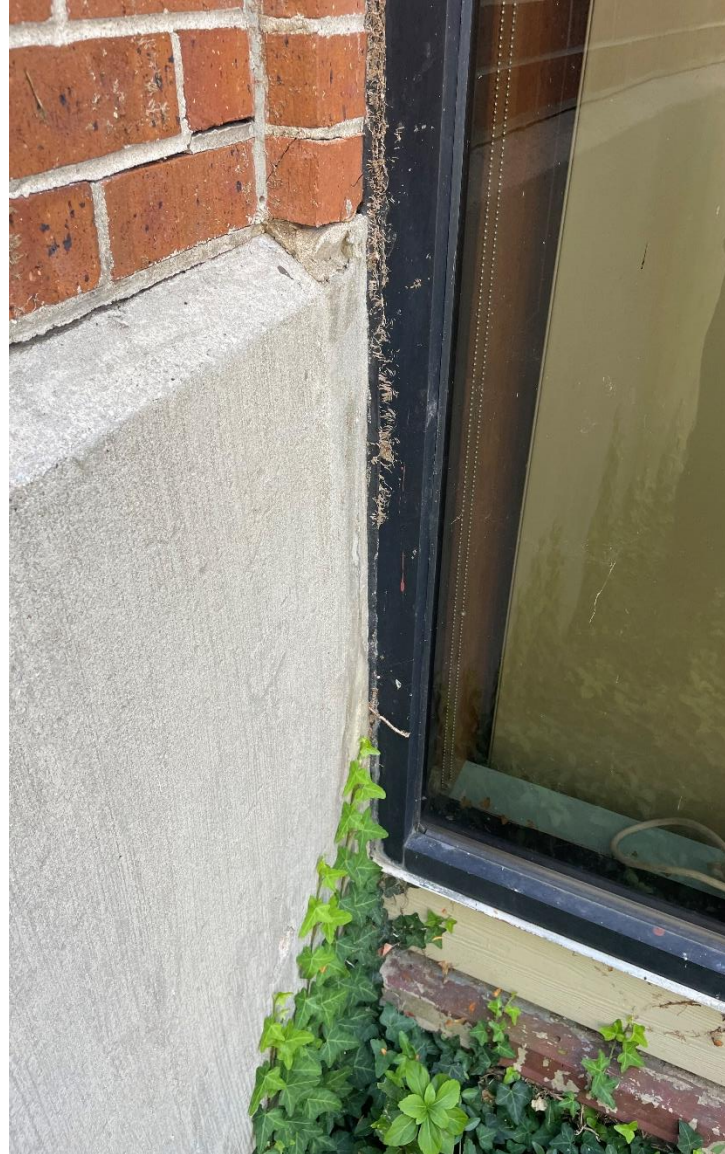
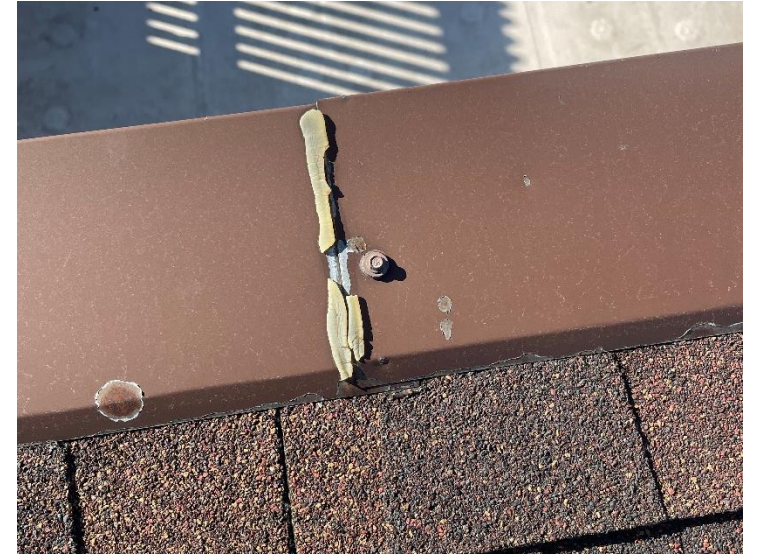
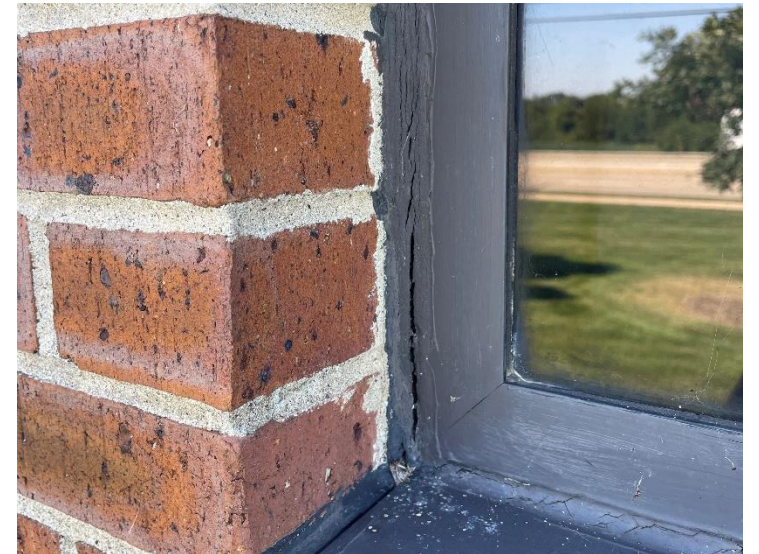
Building Envelope Sealant Joints

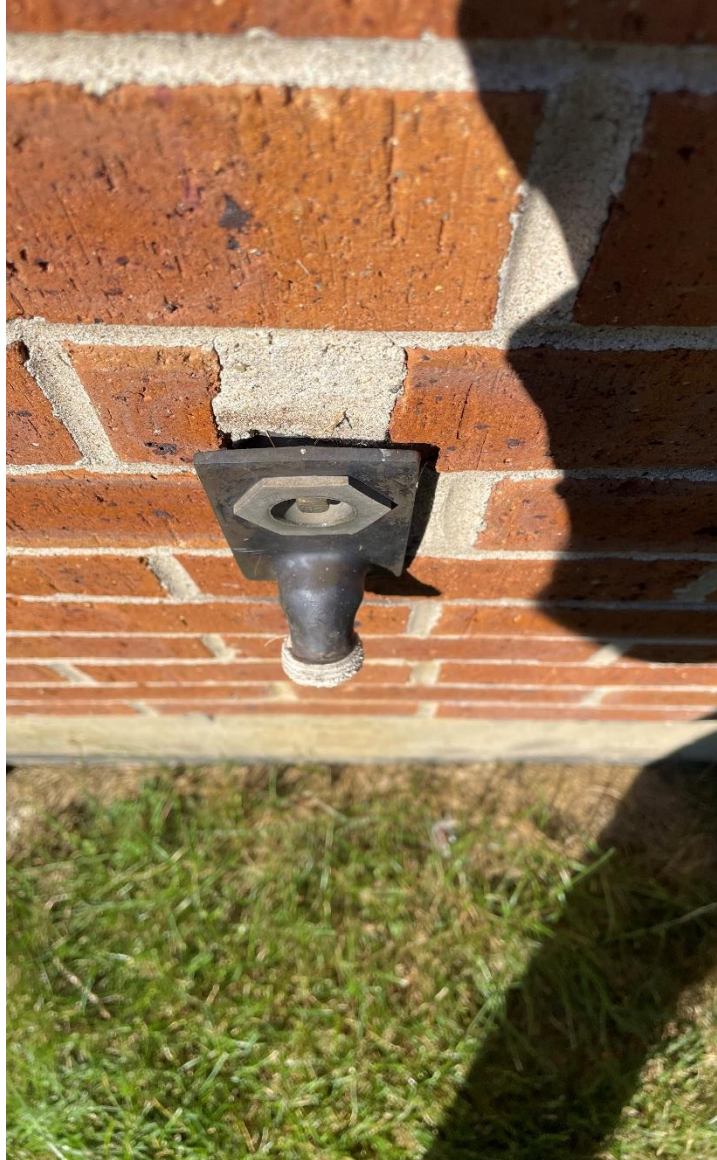
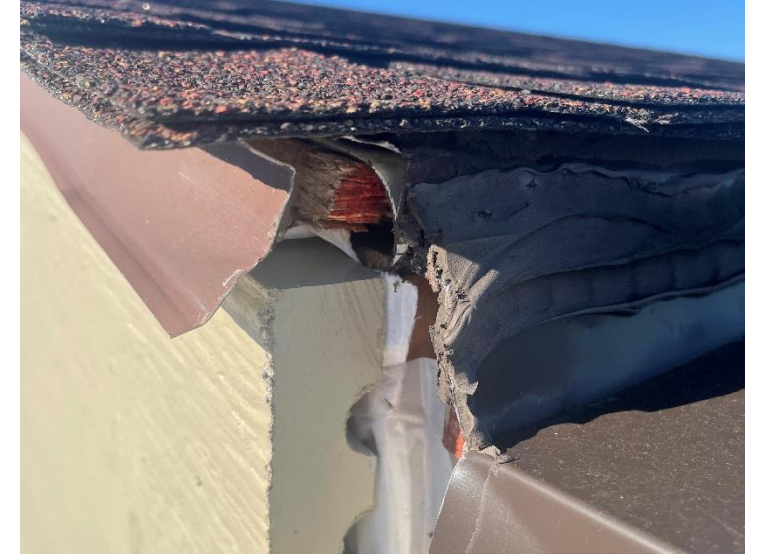
Building Envelope
Sealant Joints

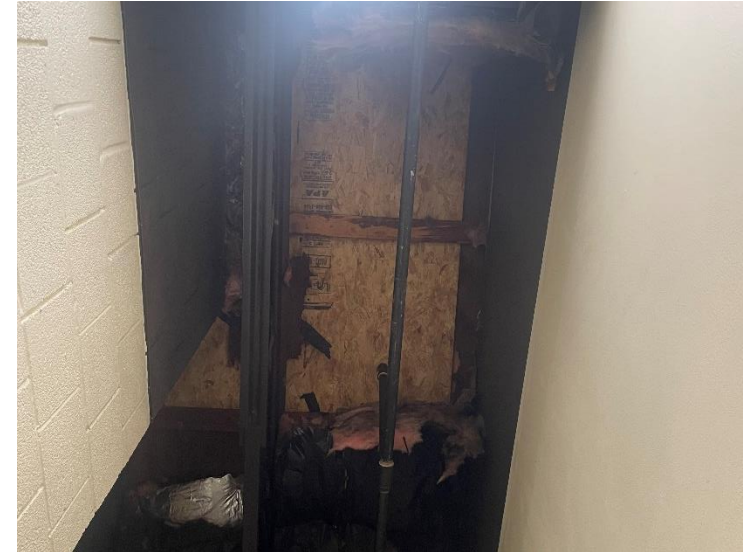
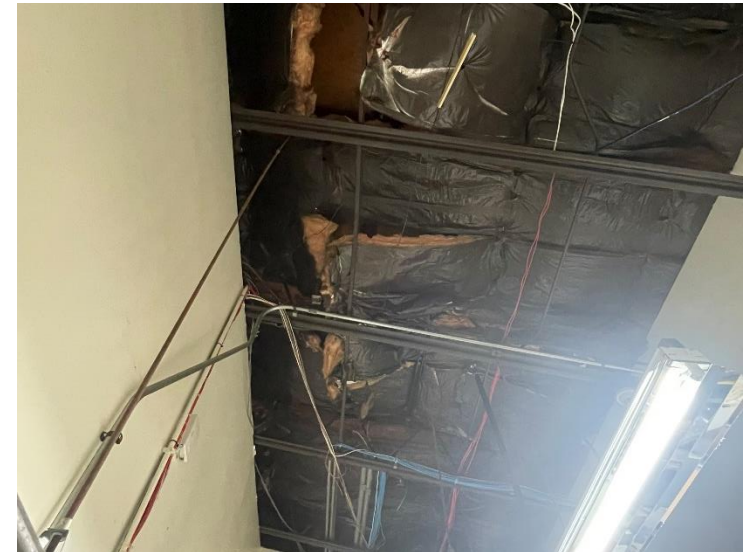
Building Envelope Insulation Integrity

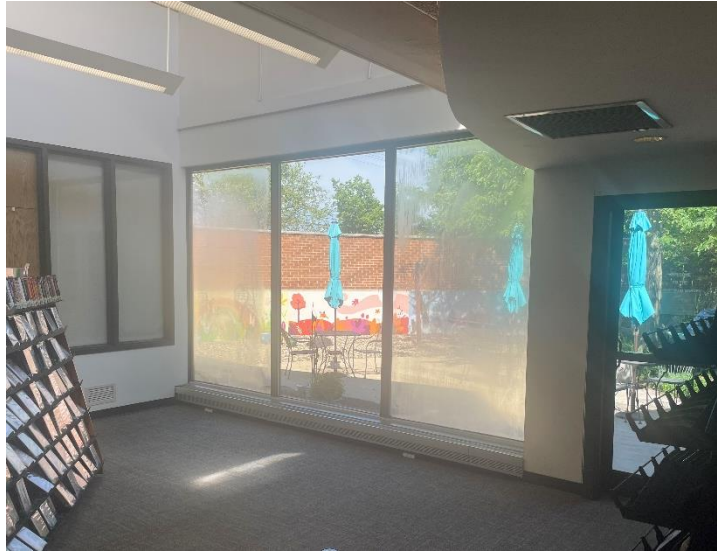
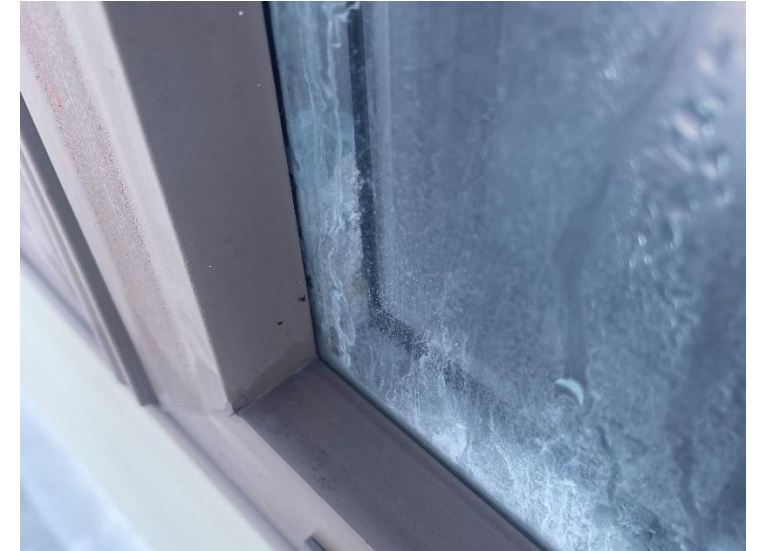
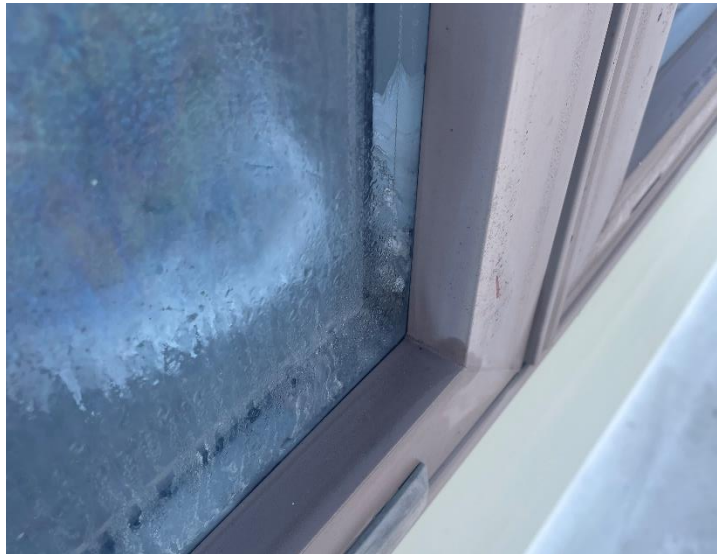
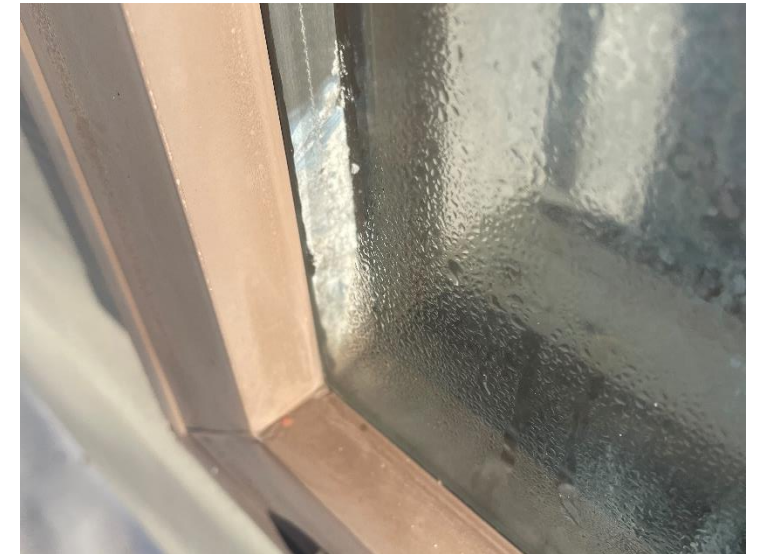
Building Envelope Window Thermal Protection
